ProtectLink Dual-Band 700/800 DAS Applies to all ProtectLink BDA's

Software Release Notes

Document Number: CS40- 734834--BDA
Revision: 7.00
Date: June 6th 2023

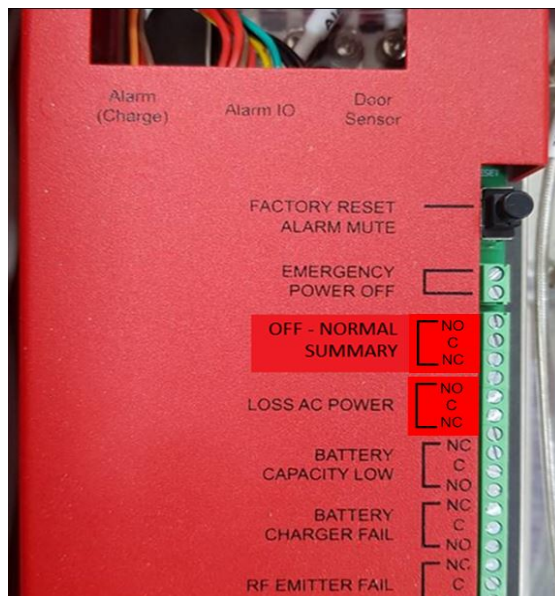
OFF - NORMAL SUMMARY
LOSS AC POWER

1. Sign into the GUI and mask all alarms on all devices from the Alarm GUI screens.
2. If the current version is pre 2.00.21, the following output relays must be re-wired according to the diagram below:

- 3 Perform the firmware upgrade from the System Settings GUI screen.
- 4 Unmask all alarms on all devices from the Alarm GUI screens.

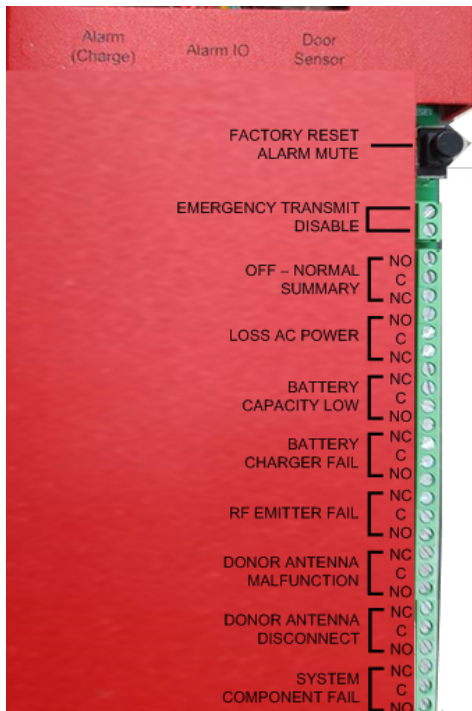
**OFF - NORMAL SUMMARY
LOSS AC POWER**

- Background: Defaulted the AC Power Fail and OFF-Normal Summary output relays to 1 which is the charged state. On alarm those relays are now set to 0 or the uncharged state. This allows the relays to indicate failure on complete loss of power by switching the NO and NC contacts.
- **MOP for Alarm Relay migration**
 1. Note the current version
 2. Sign into GUI and mask all alarms on all devices from the Alarm GUI screens
 3. If current version is pre 2.00.21 , the following output relays MUST be RE-WIRED according to the diagram below:

4. Perform the firmware upgrade from the System Settings GUI screen.
5. Unmask all alarms on all devices from the Alarm GUI screens.
