# ProtectLink Dual-Band 700/800 DAS ORU Model Numbers

# **Software Release Notes**

Document Number: CS40-734834-00D-AR/CS40-734834-00D-BR

Revision: 6.00

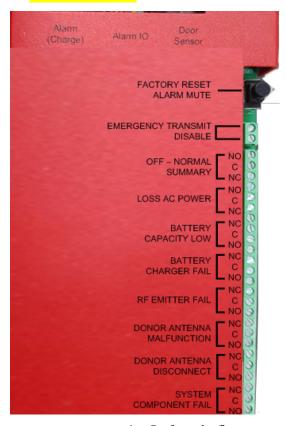
OFF - NORMAL SUMMARY LOSS AC POWER

Background: Defaulted the AC Power Fail and OFF-Normal Summary output relays to 1 which
Software Release Notes: CS40-xxxxxx-00D-AR
Rev: 6.00

is the charged state. On alarm those relays are now set to 0 or the uncharged state. This allows the relays to indicate failure on complete loss of power by switching the NO and NC contacts.

- 1. Note the current version
- 2. Sign into GUI and mask all alarms on all devices from the Alarm GUI screens
- 3. If current version is pre 2.00.21, the following output relays MUST be RE-WIRED according to the diagram below:

- 4. Perform the firmware upgrade from the System Settings GUI screen.
- 5. Unmask all alarms on all devices from the Alarm GUI screens.
