Supplemental Environmental Management Plan

Capital Improvements Projects

Great Stirrup Cay

Supplemental Environmental Management Plan Coastal Improvements Project

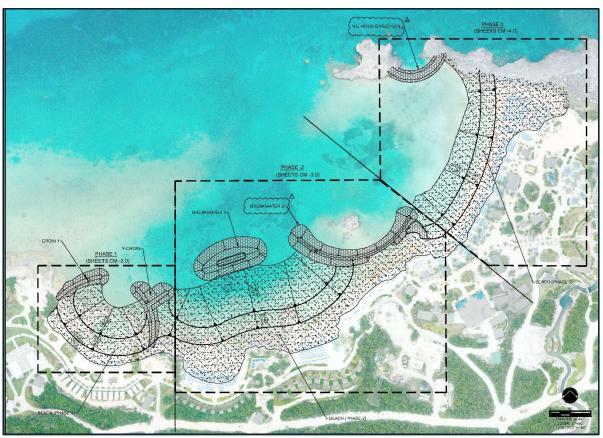
Figure 1. Coastal Improvement Project – East Beach Plan (Proposed). Source: Cummins Cederberg Coastal & Marine Engineering, Coastal Engineers (2020-06-30)

Included in this Supplemental Environmental Management Plan (EMP) is a site-specific plan developed for the Coastal Improvements Project (Project) – East Beach Plan (Figure 1) along the north coast of Great Stirrup Cay (GSC). This EMP was developed to identify and support implementation of measures to protect the environment and comply with environmental legislation. This document serves as a reference manual providing construction staff and project managers with guidelines and recommendations for adherence to Bahamian environmental regulation. The EMP contains pertinent environmental information about the Project along with Best Management Practices (BMP) intended to optimize environmental conditions during construction. This EMP is specific to marine impact avoidance/minimization associated with groin/breakwater creation and beach enhancements. The terrestrial and watershed environmental impacts and management strategies associated with upland improvements and previously completed marine-based aspects are found in the Environmental Impact Assessment (EIA) for Great Stirrup Cay (Coastal Systems International, Inc., 2008¹). This supplemental EMP is ancillary to the previously approved EIA and describes how the proposed, redesigned coastal improvement designs and activities can be implemented and constructed while minimizing potential impacts to the natural environment.

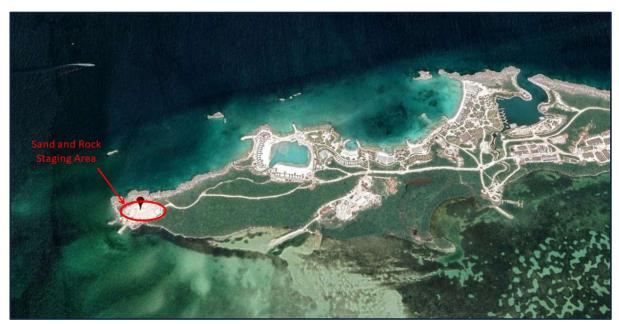
Figure 2. Sand and rock staging area

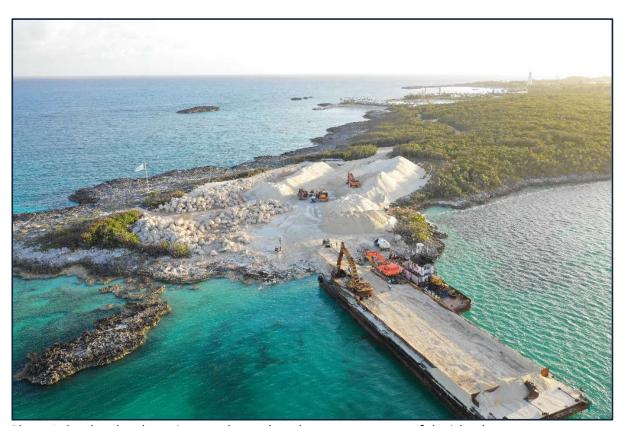
Photo 1. Sand and rock staging area located on the western corner of the island.

Per the construction plans, rocks should be rough angular quarried stone of a dense, hard durable character free of organic material. Native rock for the groin and breakwater construction is proposed to be sourced from Martin Marietta's Bahama Rock facility in Freeport. Rocks from one (1) to five (5) tons

Photo 1). Rocks will be placed in an articulated dump truck and hauled along an existing road and unloaded along the shoreline in piles. Groin 1 and the Y-Groin will be connected to land while Breakwater 1 will be constructed slightly offshore in approximately -10 fsw by creating a temporary land bridge, to be removed after completion. Breakwater 2 is connected to an existing rock structure. The N.E. Rock Structure build will also require a land bridge be installed and removed following completion of the breakwater.

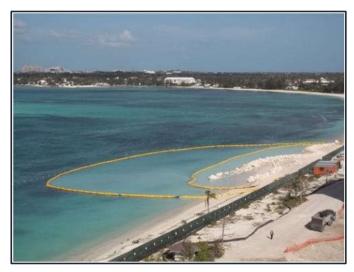
Photo 2. Example of a turbidity curtain utilized to contain turbidity. Photo from The Bahamas Weekly.

Turbidity curtains allow suspended sediment to settle out of the water column in a controlled area, thus minimizing the sediment transport from the area of disturbance. Turbidity curtains should be selected by

the contractor and be appropriate for use in tidal areas or areas where wind and wave activity may be present (Photo 2). These barriers are one of the primary methods for controlling turbidity generated from coastal construction activities. During the GSC groin/breakwater construction and beach contractors placement, should, practicable, use turbidity curtains and ensure that sufficient length of curtain remains available onsite. Turbidity barriers are less effective in project locations with high winds, open water bodies, and areas with excessive wave heights, but should be utilized whenever possible. These practices have proven themselves successful elsewhere in the Bahamas in limiting movement of silt outside

of the construction area. Daily inspections of the curtains are recommended, and repairs or replacements will be done, as necessary. Prior to removing the turbidity curtain, the turbidity inside the curtain must return to ambient conditions.

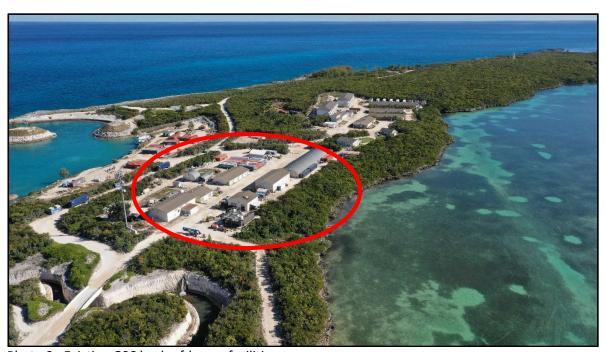
Photo 3. Existing GSC back-of-house facilities

Application of safe practice in fuel usage will minimize the likelihood of any accidental leak or spill. Contractor shall develop or utilize an existing fuel Spill Prevention and Recovery Plan. Currently, all fuel on the island is stored in a central fuel facility located within the back-of-house area (**Photo 3**). The storage tanks are double-walled and situated on an enclosed slab with surrounding concrete walls. To minimize the potential of spills, the following BMPs shall be followed:

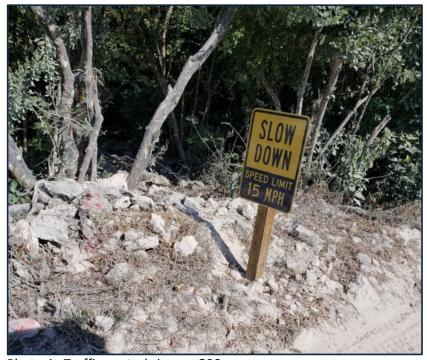
Photo 4. Traffic control sign on GSC

There will be an increase in vehicle usage and traffic during both the construction of the groins/breakwaters and beach enhancements. Vehicular traffic will include golf carts, trucks, and heavy construction equipment. Existing roads shall be used, and construction zones will be marked off to limit access from visitors while ships are in port. Coordinating construction activities while visitors are on the island shall be done to minimize potential passing of heavy equipment and vehicles while the ship is docked offshore, and passengers are on moving about GSC. Speed limit signs (**Photo 4**) shall be placed along roadsides, ingress and egress routes shall be clearly marked, and traffic cones shall be placed clearly marking of exclusion zones.

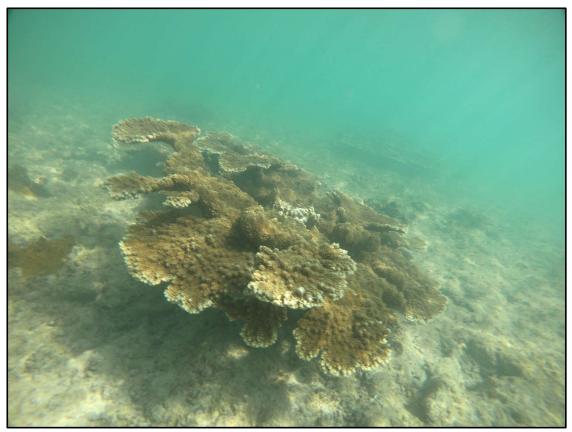
Photo 5. Elkhorn coral (Acropora palmata) (Photo credit: Cummins Cederberg, Inc.)

The area surrounding the proposed Phase 1 structures (Groin 1 and Y-Groin) was previously surveyed by NOVA Southeastern University (various dates); the survey documented elkhorn coral (*Acropora palmata* [Photo 5]) and staghorn (*Acropora cervicornis*) coral colonies (Figure 3). In March 2020, Cummins Cederberg, Inc. conducted a benthic survey to specifically document marine habitats around the proposed Phase 2 structures (Breakwater 1 and Breakwater 2) [Figure 4] and Phase 3 structure (N.E. Rock Structure) [Figure 5]. The survey characterized the benthic habitat and their extents within the footprints of the proposed breakwater structures and areas surrounding the proposed breakwaters, as well as documented the location of coral colonies. The full report is provided in Appendix C.

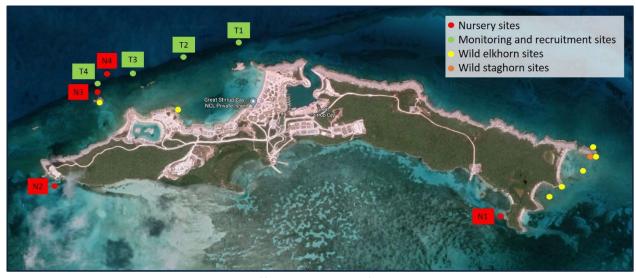
Figure 3. Elkhorn and staghorn coral sites (figure credit: NSU)

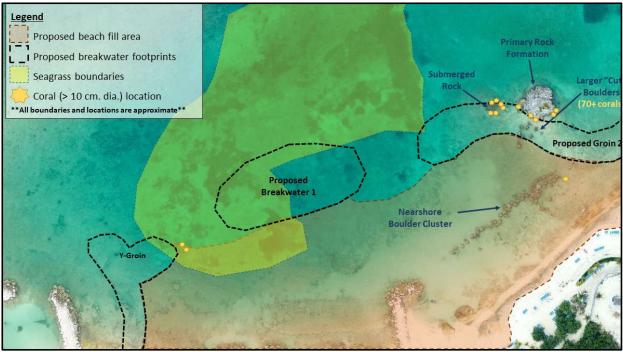
Figure 4. Marine habitats around proposed Breakwater 1 and Breakwater 2 (Phase 2, before redesign) (Cummins Cederberg, 2020)

The nearshore submerged substrate adjacent to the beach where Breakwater 1 and Breakwater 2 are located generally consists of sand and occasional larger rocks (50 cm – 1 m). Approximately 250 linear feet (LF) waterward (north) toward the footprint of Breakwater 1, the substrate transitions to fractured carbonate rock and hardbottom covered in various fleshy brown and green algae, with occasional small colonies (<5-7 cm [2-3 inches]) of the ubiquitous starlet corals (*Siderastrea spp.*) and small octocorals, with scattered patches of turtle grass (*Thalassia testudinum*). Progressing northward, the turtle grass habitat transitions to a denser mixed seagrass bed of turtle grass and manatee grass (*Syringodium filiforme*) which continues for another approximately 30 LF where it becomes less dense, continuing northward well beyond the survey area. The seagrass bed continues east and west and transitions to patchy seagrass and eventually back to fractured carbonate rock colonized with macroalgae. On the western extent of the proposed beach fill footprint, are two large (>1.5 m [5 feet] in diameter) boulder

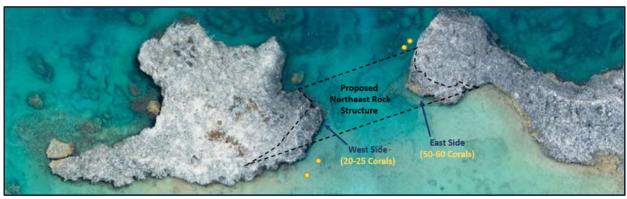
Figure 5. Coral colonies around proposed N.E. Rock Structure (Phase 3, before redesign) (Cummins Cederberg, 2020)

The original design configuration for the N.E. Rock Structure (Phase 3) encompassed deeper water to the north where larger boulders in approximately 18-20 fsw are scoured from heavy waves and have very few coral colonies colonizing them. However, along the shallower sloping rock faces on the eastern side of the original design, there were numerous coral colonies (50-60) growing on the vertical and horizontal substrate, and beneath overhangs. An additional 20-30 colonies were observed within the westernmost extent of the footprint. **Figure 5** shows the locations of the coral colonies observed and documented during the March 2020 survey.

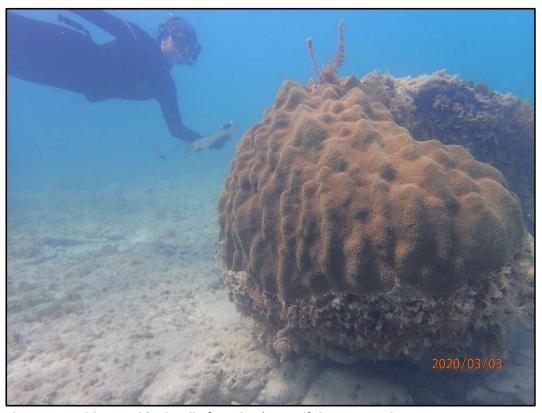
Photo 6. Boulder coral (Orbicella faveolata) east of the proposed Y-Groin

corals (*Orbicella faveolata* [**Photo 6**]) outside of the proposed breakwaters but potentially within the beach fill area.

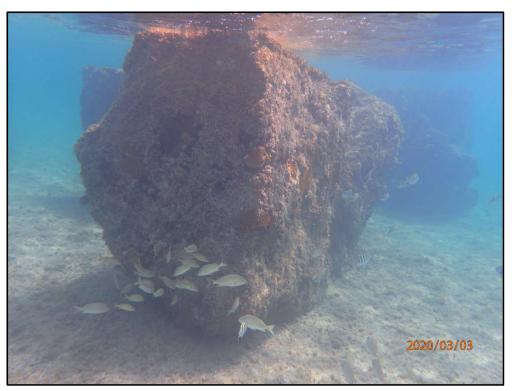
Photo 7. Cube-shaped boulder near proposed Breakwater 2

The original design footprint of Breakwater 2 (Figure 6) encompassed a natural emergent rock formation as well as approximately a dozen 'cut' boulders in the shape of cubes (~ 6'L x 6'W x 6'H) that appear to be manufactured and placed on site many years ago (Photo 7). Coral were present on the sloping and vertical faces of the primary rock formation, the submerged natural rock, and on the sides of the larger "cut" boulders. There were approximately 60 colonies of finger coral, Porites porites, and 10 colonies of mustard hill coral, P. astreoides, that were ≥10 cm observed growing on the cut boulders. Macroalgae, sponges, and fire coral (Millepora spp.) were also observed growing on the boulders. On the south side of the rock formation and the adjacent submerged rock to the west, eleven colonies ≥10 cm of varying coral species were documented. Corals were observed growing on the north side of the rock; however, this is outside of the project area, so the corals were not enumerated. To the southwest and closer to shore, another cluster of smaller boulders are present; these colonies are primarily colonized by macroalgae with only a few small starlet corals observed. One knobby brain coral colony (Pseudodiploria clivosa [Photo 8]), approximately 0.7 m. x 0.45 m., was documented growing on the substrate directly southeast of the nearshore boulders, approximately 130 LF south of the rock formation. The general extents of these benthic habitats, key features, and coral colonies are shown presented in Figures 4 and **5** and the entire report is provided as **Appendix C**.

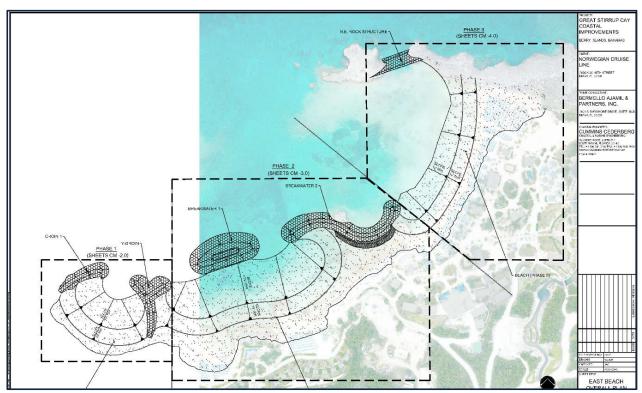
Figure 6. Original design of Breakwater 2 and the N.E. Rock Structure before benthic habitat survey and redesign (Source: East Beach Plan, Cummins Cederberg Coastal and Marine Engineering (2019-12-02)

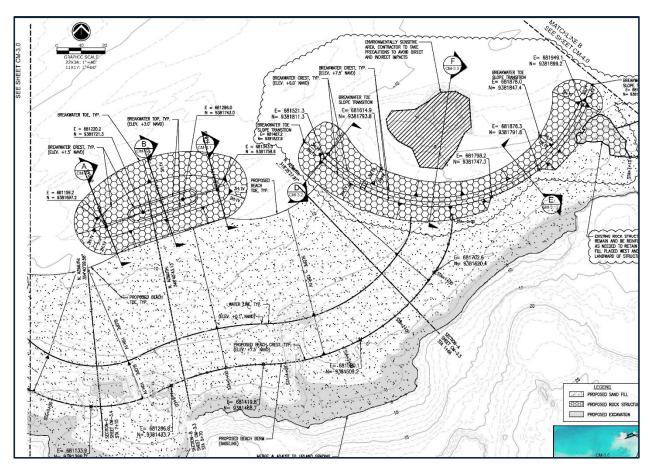
Figure 7. Redesign of Breakwater 2 (Source: East Beach Plan, Cummins Cederberg Coastal and Marine Engineering (2020-04-16)

areas with corals to avoid previously anticipated impacts, while maintaining beach stabilization functionality. During construction, contractors should use the benthic habitat map (**Figure 4**) to identify and clearly mark the location of coral colonies within the immediate surrounding area with high-visibility buoys, follow the turbidity control plan, and inspect the coral colonies following construction to document coral colonies were not impacted during construction.

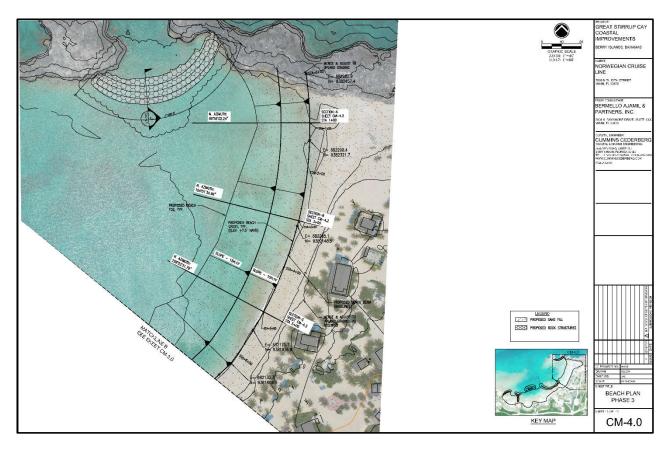
Figure 8. Redesign of the N.E. Rock Structure (Source: East Beach Plan, Cummins Cederberg Coastal and Marine Engineering (2020-06-03).

To avoid impacts to coral colonies during Phase 3 (N.E. Rock Structure), the location and configuration of the design was shifted to avoid corals colonized on the western and eastern vertical slopes and beneath overhangs. The new redesign (**Figure 8**) located the structure southward, thereby avoiding direct impacts to 70 to 90 coral colonies.

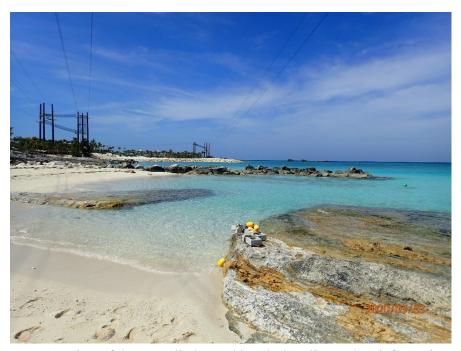
Photo 1. View of the centrally located beach shoreline and rock formation used as reference, looking west.

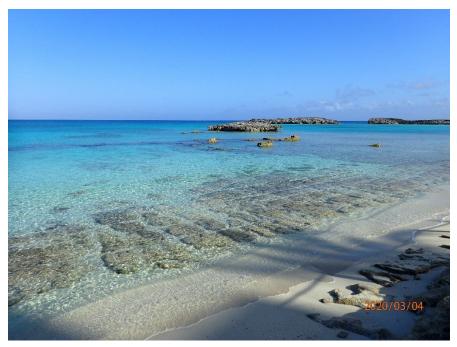
Photo 2. Northeast view of the natural occurring rock formation where Breakwater 2 is proposed.

The design footprint of Breakwater 2 incorporates a natural emergent rock formation (as seen in **Photo 2**) as well as approximately a dozen 'cut' boulders in the shape of cubes (~ 6 'L x 6'W x 6'H) that appear to be manufactured and placed on site many years ago. Coral were present on the sloping and vertical faces of the primary rock formation, the submerged natural rock, and on the sides of the larger "cut" boulders (**Photo 8**). There were approximately 60 colonies of finger coral, *Porites porites*, and 10 colonies of mustard hill coral, *P. astreoides*, that were ≥ 10 cm observed growing on the cut boulders. Macroalgae, sponges, and fire coral (*Millepora spp.*) were also observed growing on the boulders. On the south side of the rock formation and the adjacent submerged rock to the west, eleven colonies ≥ 10 cm of varying coral species were documented (**Photo 9**). Corals were observed growing on the north side of the rock; however, this is outside of the project area, so the corals were not enumerated. To the southwest and closer to shore, another cluster of smaller boulders are present (**Photo 10**); these colonies are primarily colonized by macroalgae with only a few small starlet corals observed. One large *Pseudodiploria clivosa* colony (0.7 m. x 0.45 m.) was documented growing on the substrate (**Photo 11**) directly southeast of the nearshore boulders, approximately 130 LF south of the rock formation.

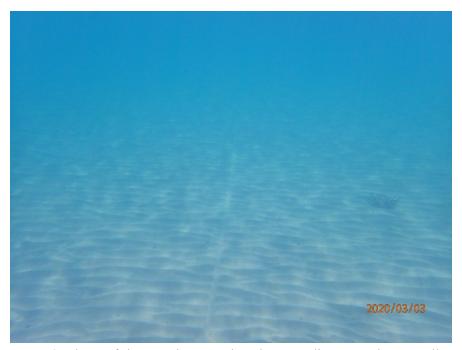
Photo 3. Photo of the nearshore sandy substrate adjacent to the centrally located beach.

The nearshore submerged substrate adjacent to the beach where Breakwater 1 and Breakwater 2 are located generally consists of sand (**Photo 3**) and occasional larger rocks. Approximately 250 linear feet (LF) waterward (north) toward the footprint of Breakwater 1, the substrate transitions to fractured carbonate rock (**Photo 4**) and hardbottom covered in various fleshy brown and green algae (**Photo 5**), with occasional small colonies (<5-7 cm [2-3 inches]) of the ubiquitous starlet corals (*Siderastrea spp.*) and small octocorals, and scattered patches of turtle grass (*Thalassia testudinum*). Progressing northward, the turtle grass habitat transitions to a denser mixed seagrass bed (**Photo 6**) of turtle grass and manatee grass (*Syringodium filiforme*) which continues for another approximately 30 LF where it becomes less dense, continuing northward well beyond the survey area. The seagrass bed continues east and west and transitions to patchy seagrass and eventually back to fractured carbonate rock with macroalgae. On the western extent of the proposed beach fill footprint, there are two large (>1.5 m [5 feet] in diameter) boulder corals (*Orbicella faveolata*) (**Photo 7**) outside of the proposed breakwaters but potentially within the beach fill area. The general extents of these benthic habitats, key features (e.g. rock formations) and coral colonies are shown in **Figure 2**.

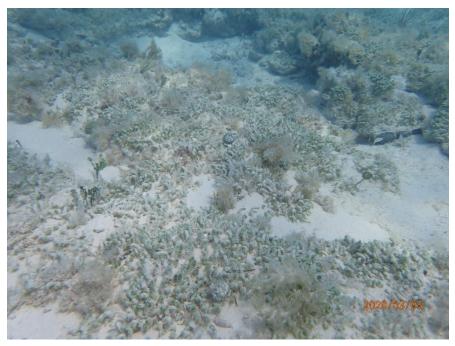
Photo 4. Example of fractured carbonate rock hardbottom and macroalgae overgrowth observed during the survey.

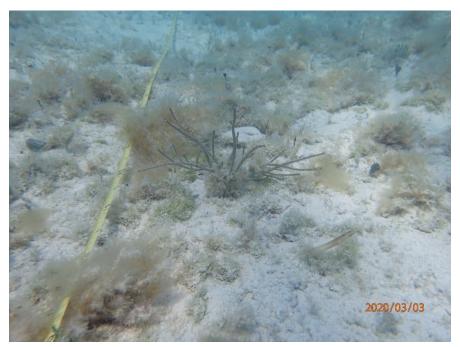
Photo 5. Example of the brown algae overgrowth observed within the centrally located beach submerged lands.

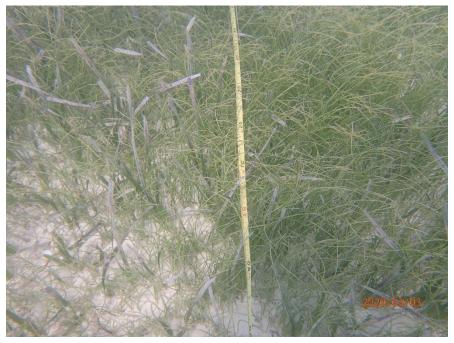
Photo 6. Mixed seagrass present offshore of the central beach shoreline.

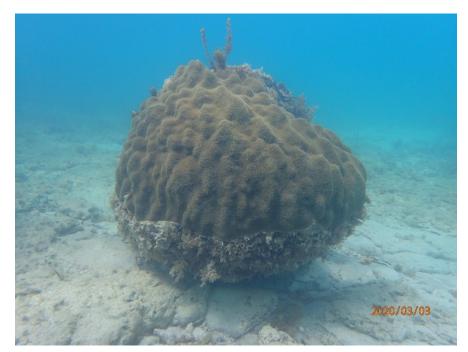
Photo 7. One of the *Orbicella faveolata* boulder corals documented west of Breakwater 1 footprint.

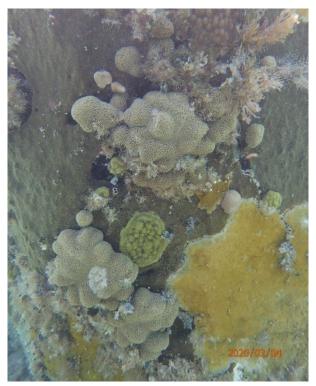
Photo 8. Example of the coral colonies on the larger, cut boulders located southwest of the rock formation within the Breakwater 2 footprint.

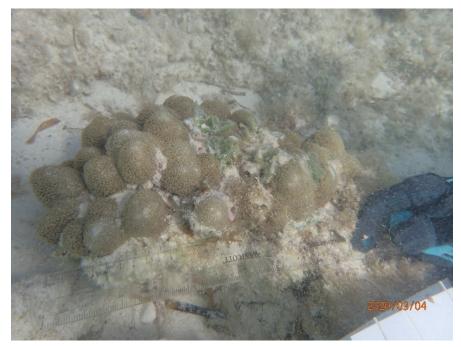
Photo 9. Example of a coral colony (*P. porites*), > 10 cm, on the south side of the rock formation with Breakwater 2 footprint.

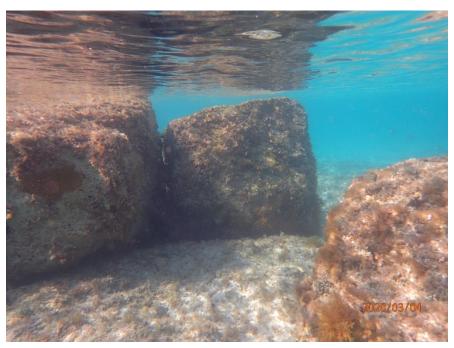
Photo 10. Smaller, nearshore boulders southwest of the Breakwater 2 footprint.

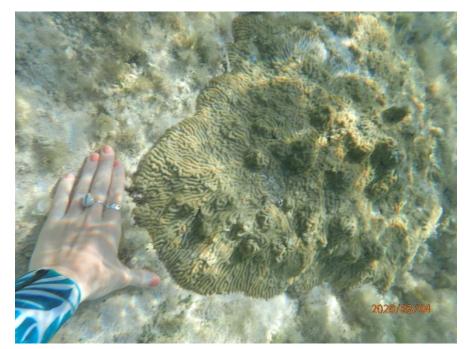
Photo 11. *P. clivosa* colony documented south Breakwater 2.

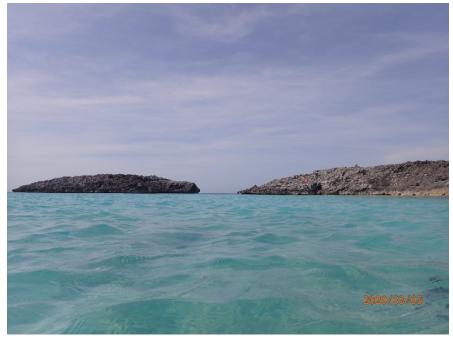
Photo 12. The two large natural rock formations that the "Northeast Rock Structure" is proposed to be constructed between.

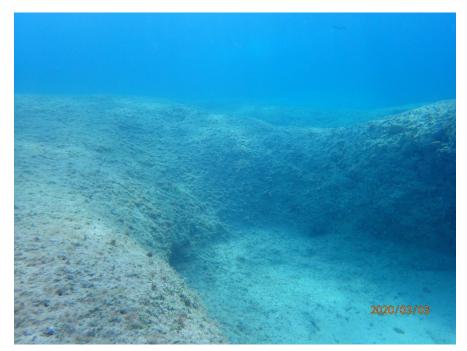
Photo 13. Scoured rocks and sand patch at the bottom of the seabed where "Northeast Rock Structure" is proposed, looking north.

and interspersed with sand depressions (**Photos 13** and **14**). Few coral colonies are present within the central sections, likely due to the heavy wave action causing the boulders to be nearly barren of marine growth. Further north and outside of the project area, water depths increase and the benthic community transitions to a sandy bottom with scattered, large rock formations. Along the eastern and western perimeters of the footprint and along the slopes of the rock formations (**Photos 15 and 16**), approximately 50-60 coral colonies (≥10 cm) were observed on the sloping rock, vertical faces, and overhangs. Approximately 20-30 colonies were observed within the western extent of the footprint. Species observed included *Agaricia spp.*, *P. astreoides*, *P. clivosa*, and *Siderastrea siderea* (**Photos 17 - 19**).

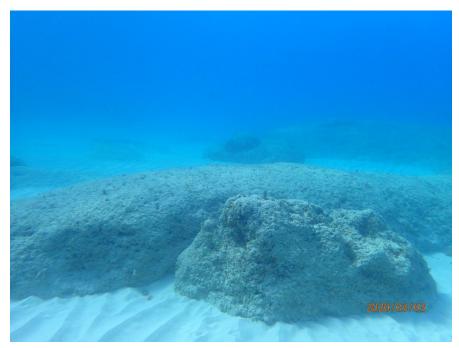
Photo 14. View of the seabed looking north of where "Northeast Rock Structure" is proposed.

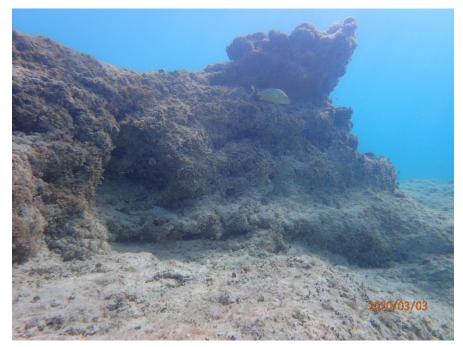
Photo 15. Example of rock formation within "Northeast Rock Structure" footprint.

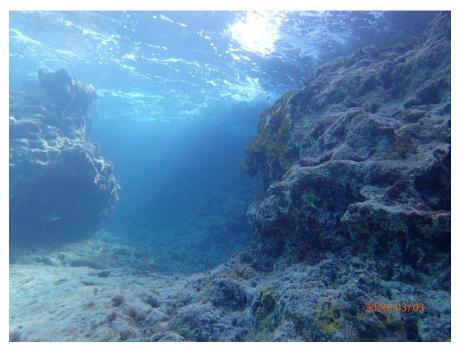
Photo 16. View of the bottom of the seabed where "Northeast Rock Structure" is proposed, looking south.

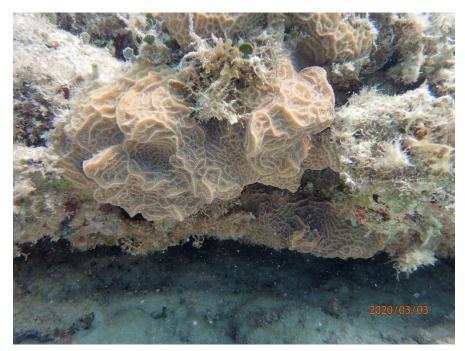
Photo 17. A colony of *Agaricia agaricites* growing on the rock overhangs present within the proposed footprint of "Northeast Rock Structure."

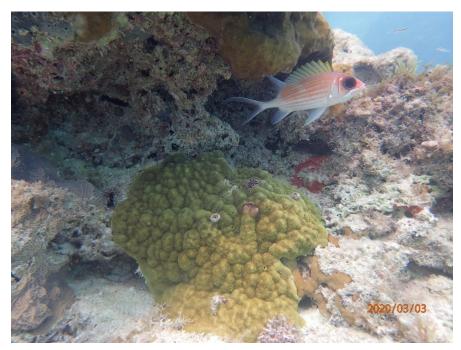
Photo 18. A colony of *P. astreoides* colony within the proposed footprint of the "Northeast Rock Structure."

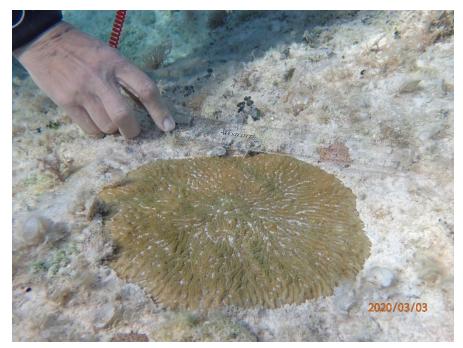
Photo 19. Example of a *P. clivosa*, >10 cm, observed growing on a rock within the proposed footprint the "Northeast Rock Structure."
