ALUMINIZED STEEL TYPE 2

FABRICATION DATA

Technical Bulletin

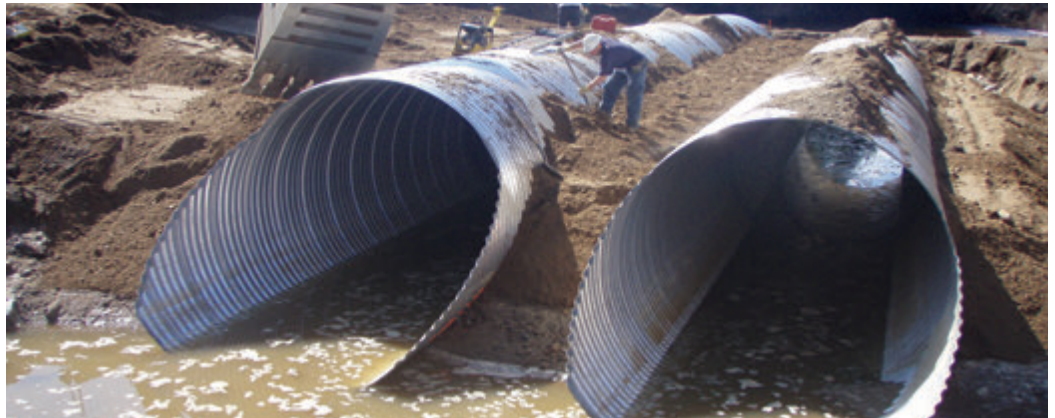
WELD SEAMS

Substrate at seams is protected by electrochemical behavior of the Al and Al-Fe coating layers.

RE-ROLLED ENDS

The double corrugation process at pipe ends does not adversely affect the performance of Type 2.

LOCKSEAMS/ SPIRAL RIBS

Coating fissures are plugged as a result of the electrochemical behavior of the coating.

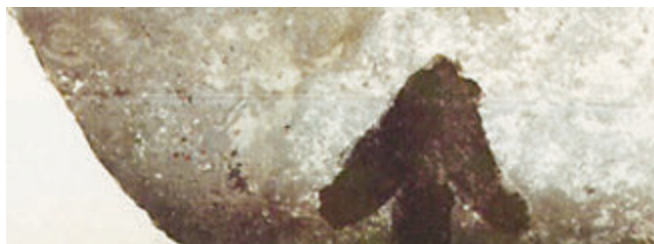
Thirty-year-old aluminized uncoated edge on a triangular notch cut from an invert handling water corrosive to galvanized. The undeteriorated edge is indicated by the arrow.

During pipe manufacturing, re-rolled ends show a few small spots of spalled coating around the pipe circumference. This is due to reverse double bending of pipe material at these spots. Coating electrochemical behavior provides corrosion protection at re-rolled ends, as it does at weld seams. Actually, there is further protection in that the spots retain a skin of protective intermetallic alloy layer. Re-rolled ends can be painted for cosmetic purposes. The full extent of substrate protection was demonstrated by the minimal corrosion at original cut edges on riveted pipe exposed in the field for times up to 50 years.
