# **Environmental Impact Assessment (EIA)**

Proposed Pier and Harbour Development

### **Great Stirrup Cay**

The Berry Islands, Bahamas

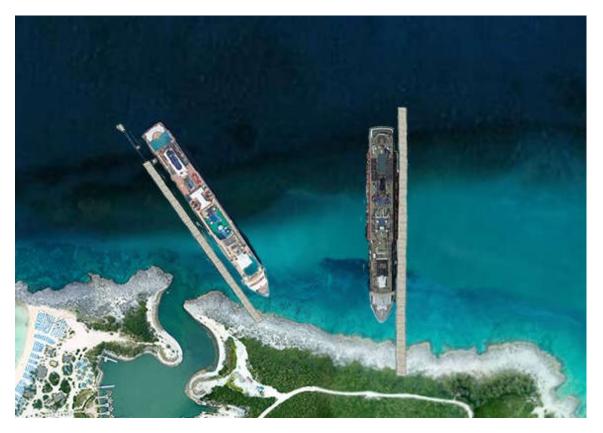
Figure 3: Northern shoreline showing proposed cruise ship piers

piers are proposed, there are no existing marine or shoreline structures, infrastructure, or land-access points, with the exception of the marine harbour west of the proposed piers (**Figure 3**).

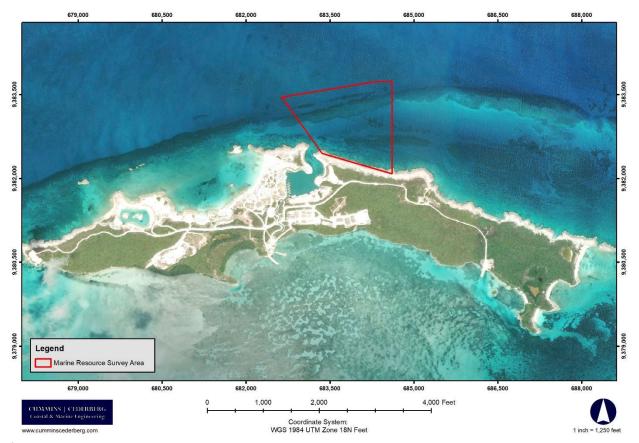
Figure 4: Marine survey area

A detailed marine resource survey and habitat mapping effort was conducted in July 2020 using a range of survey techniques to document, characterize, and quantify sensitive marine habitats within the Project area. The survey was designed to assess the density of hard corals (Scleractinian) and soft corals (octocorals), determine the condition and quantity of submerged aquatic vegetation, map the habitat transitions from the shoreline waterward, and document the presence of other marine resources. Additionally, fish and invertebrate species observed during the survey were noted to create a qualitative list of notable species within the survey area. The survey area is outlined in **Figure 4**.

The marine habitat within the survey area transitioned from a sloping hardbottom community comprised of uncolonized hard substrate to sparsely colonized by hard corals and octocoral colonies. Progressing offshore is the higher-relief (>1 meter) contiguous reef ridge with the highest coverage and density of hard corals, including larger boulder colonies. North of the contiguous reef ridge is a prominent sand gap feature that transitions into the reef flat habitat, a lower-relief habitat with fewer hard coral colonies than the neighboring aggregate patch reef ridge to the north or the contiguous reef ridge to the south. The aggregate patch reef ridge was documented to have a slightly higher percent coverage of living corals but a slightly lower density of large colonies than the continuous reef ridge, although both habitat types were documented as the predominant reef features harboring a range of species and size of hard corals and octocoral colonies within the survey area. Baseline conditions and more detailed descriptions are provided in **Section 4.5.1.** The full survey methodologies and results can be found in **Appendix A**.

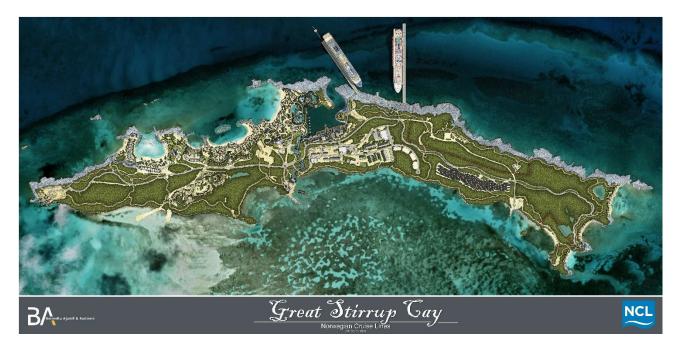
Figure 5: GSC Master Plan with cruise ship pier layout (illustrative purposes only)

The GSC cruise pier Project is located on the north side of GSC and includes dredging to accommodate the NCL cruise fleet; the construction of two piers (an East and West Pier) and associated mooring bollards, dolphins, and catwalk system; and utilities to support ship services. **Figure 5** shows the general location and layout of the proposed piers configuration as part of the Master Plan for the island.

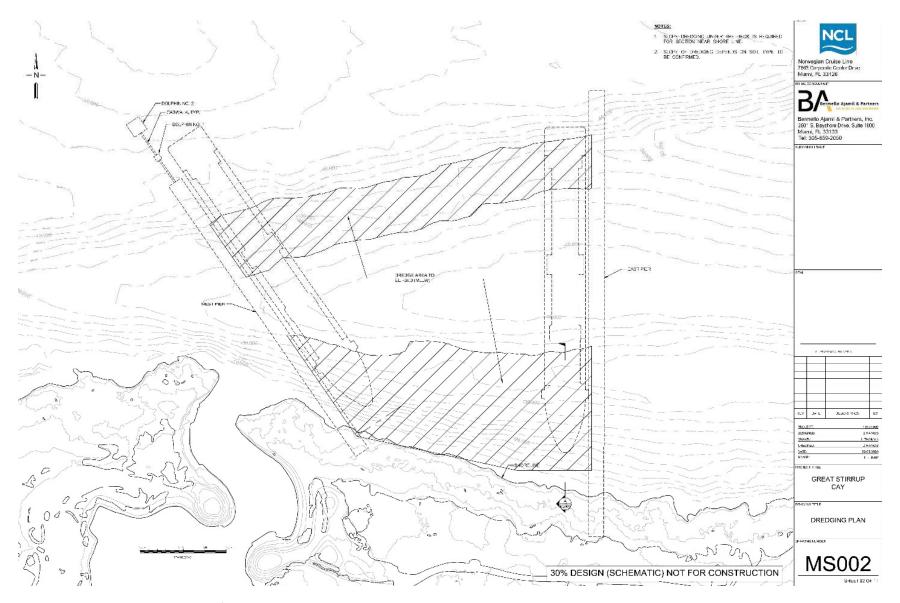
Figure 6: Proposed dredging plan for the cruise ship piers on GSC

Dredging between the East and West Piers shall be to an elevation no less than -34.0 ft (-10.4 m), MLLW with an over dredge limited to 2 ft. The total estimated footprint of the dredge area is approximately 12.5 acres, with approximately 150,000 CY of material being removed. Slide slopes will generally be cut at a stable slope or step-wise manner corresponding to the material encountered. No blasting is proposed or allowed. **Figure 6** shows the 30% proposed dredging plan for the Project; the final volumes and area to be dredged will be determined by the contractor following completion of detailed design-build methods and dredge operation plans. See **Appendix F** for the full 30% drawing set of the proposed dredging and pier construction.

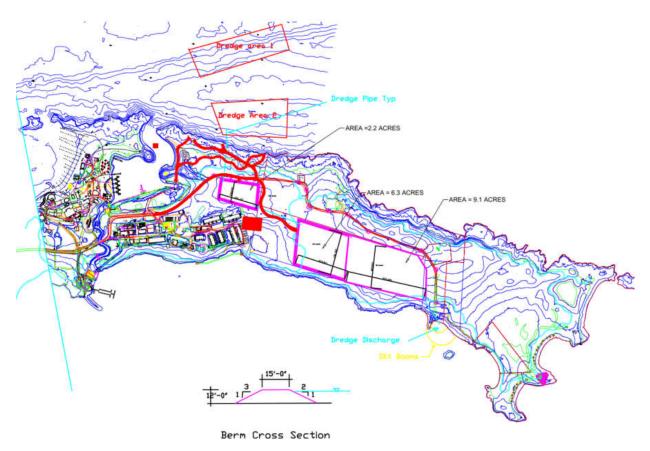
**Figure 7:** Proposed dredge areas (red polygons), dredge material settling ponds (pink polygons), roadways, paths, and dorms (solid red lines), and pipeline corridor (hatched red lines)

Offshore material disposal was not considered due to the potential environmental considerations and opportunity for material re-use on island. Dredge material will be discharged upland into three confined upland disposal areas (settling ponds) on the south side of the island (Figure 7) estimated to total approximately 17.6 acres; an additional 3.5 acres will be cleared to support construction laydown areas and future roadways, paths and back-of-house infrastructure and staff housing as shown in Figure 7 The two main objectives inherent in design and operation of confined upland disposal areas are adequate storage capacity and efficiency in retaining the solids. When the dredged material is initially deposited in the settling ponds, the discharge may occupy several times its original volume, but over time, the sediment will eventually consolidate as effluent and desiccation occur.

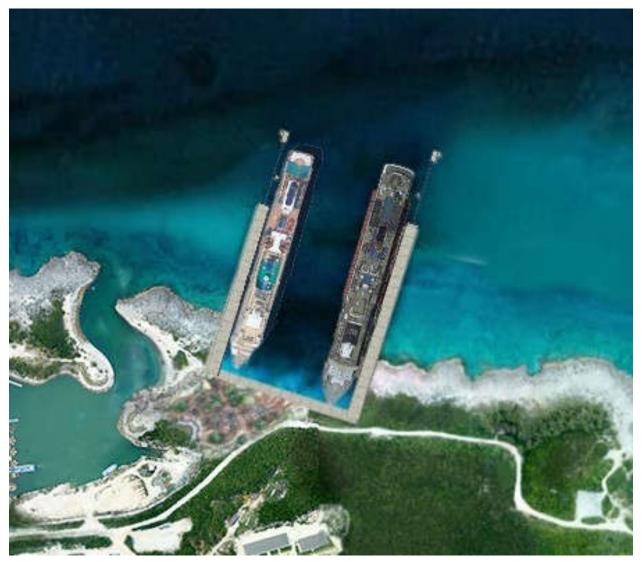
Figure 8: Alternative 1

Alternative 1 (**Figure 8**) utilized two parallel fixed piers of concrete and steel sheet piles extending northeast from the island just east of the existing marine harbour. These piers were to be of compacted earth from excavated dredge material to provide bathymetry deep enough for cruise ship mooring. The two extending piers were to be 900 ft long and 50 ft wide with a gap of 600 ft between the inside faces of the piers. Two dolphin piles were to be spaced 100 ft apart on center at the end of each pier for mooring stability, and one large dolphin pile of 50 ft by 50 ft was to be added 100 ft after the smaller dolphin piles

Alternative 1 has large environmental impacts due to the fixed piers and upland dredging. The piers covered approximately 90,000 SF of seabed/upland and prevent the opportunity for hydrodynamic flow through the piers. The fixed piers also created concerns regarding wave action where internal seiching could become an issue. Without wave attenuation and the opportunity for vessel wakes to escape from within the piers, waves from cruise ships and tugboats will reflect off the pier walls and interact with other waves causing constructive interference. This could cause vessels to batter the piers and create unfavorable docking conditions.

Regarding the environmental aspects of Alternative 1, the removal of approximately 192,500 SF of upland ironshore and vegetation would be costly and negatively impact the local ecosystem. This excludes the nearshore dredging that would be needed to provide depths deep enough for cruise ships to safely moor. Due to the high quantity of dredging and associated costs, environmental concerns, and potential for large waves from seiching between the piers, Alternative 1 was not chosen for development.

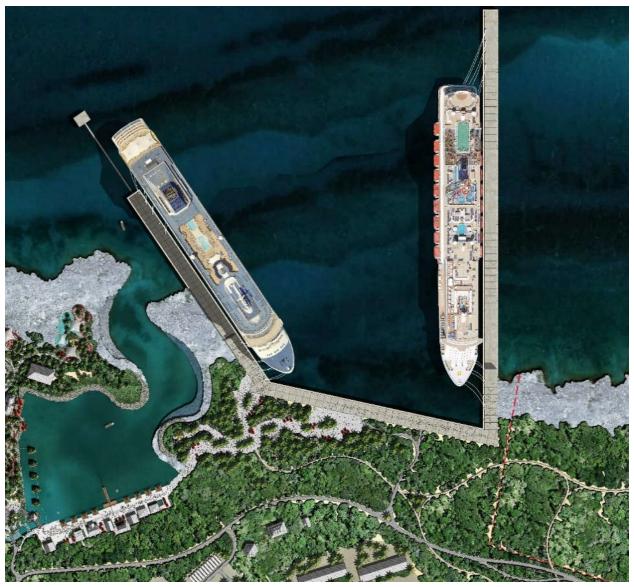
Figure 9: Alternative 2

Alternative 2 (**Figure 9**) utilized similar concepts as Alternative 1 with fixed piers of concrete and steel sheet piles extending from the island just east of the existing lagoon. However, Alternative 2 altered the length and direction of each pier. Rather than a northwest direction, the easternmost pier (East Pier) was designed to be constructed in a north-south direction, and the westernmost pier (West Pier) was designed to be in a northwest-southeast direction. Both piers were to be of compacted earth from excavated dredge material, similar to Alternative 1.

Regarding the environmental aspects of Alternative 2, the removal of approximately 166,500 SF of upland ironshore and vegetation would be costly and negatively impact the local ecosystem. This excludes the nearshore dredging that would be needed to provide depths deep enough for cruise ships to safely moor. Due to the high quantity of dredging and associated costs, environmental concerns, and potential for large waves between the piers, Alternative 2 contained similar concerns to that of Alternative 1 and therefore was not selected for development.

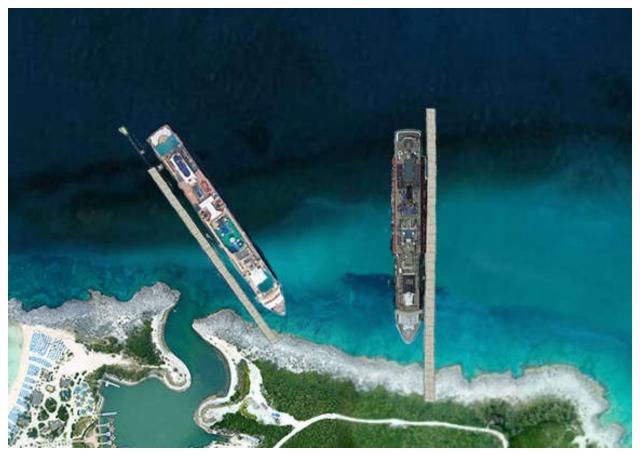
Figure 10: Alternative 3

While the preferred alternative will result in some negative impacts, the changes proposed will overall result in improved functionality over the No-Action Alternative. Alternative 3 utilizes one fixed pier of concrete and steel sheet piles extending north from the island (East Pier) and one fixed pile-supported pier extending to the northwest (West Pier), as seen in **Figure 10** and in **Appendix E.** The East Pier is to be composed of similar materials suggested in Alternatives 1 and 2; this includes the steel pipe and sheet pile combi-wall system with a cast-in-place concrete slab cover surrounding the compacted earth from dredge material (beneficial re-use of dredge spoils). The West Pier is to be a pile-supported system composed of steel batter pipe piles and a precast concrete pile cap encasing the top of the piles. The East Pier is to be 1,198 ft long and 50 ft wide with an additional 202 ft of pile-supported pier and 100 ft of concrete slab-on-grade landward of the combi-wall system to provide a safe pathway for visitors. The West Pier shall be 1,052 ft long and 50 ft wide with an additional 48 ft of concrete slab on grade landward of the Pier for pedestrian traffic. A 20-ft by 20-ft dolphin pile is to be placed 90 ft after the end of the West Pier for mooring stability, and one large dolphin pile of 50 ft by 50 ft is to be added 90 ft after the smaller dolphin pile as anchorage for the piers and cruise ships.

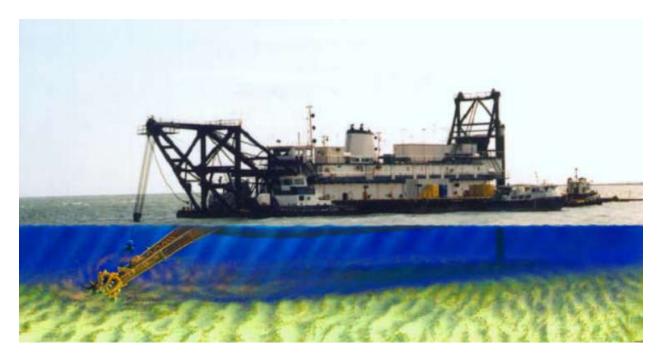
Figure 13. Illustration of cutter suction dredge

Capital dredging is proposed to create adequate water depths to accommodate the cruise vessels to a depth of no less than -34.0 ft (-10.4 m), MLLW. Due to the geology of the site, dredging will likely be completed by a cutterhead suction dredge (**Figure 13**) with either a 30 or 36-inch diameter cutterhead. Cutter suction dredges are generally used for dredging harder materials and pumping short distances. The dredge will set up at the northernmost edge of the dredge field and work south towards the shore. From the cruise harbour, dredged material will be pumped as a slurry through high-density polyethylene (HDPE) pipes that will be sized to match the cutterhead discharge. Pipes will be routed from the cutterhead and primarily along existing roadways and disturbed areas to the first of three confined upland disposal areas (settling ponds) on the south side of the island (**Figure 7**). The contractor will take periodic soundings to verify that the design depths have been met. At the conclusion of the dredge, the contractor will submit a complete bathymetric survey of the dredged areas and surrounding waters. A detailed dredge

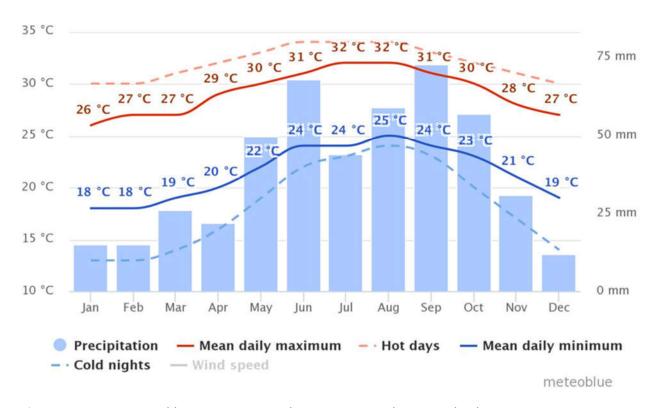
Figure 14: Average monthly temperatures and precipitation in the Berry Islands

The mean daily maximum temperature during January in the Berry Islands is 26°C (79°F) with the average minimum 18°C (64°F), while in September the average maximum is 31°C (88°F) with a minimum of 24°C (75°F). The average precipitation in GSC peaks in the late summer (September) with ~75 mm. The driest months are December through April with precipitation of less than ~25 mm per month.

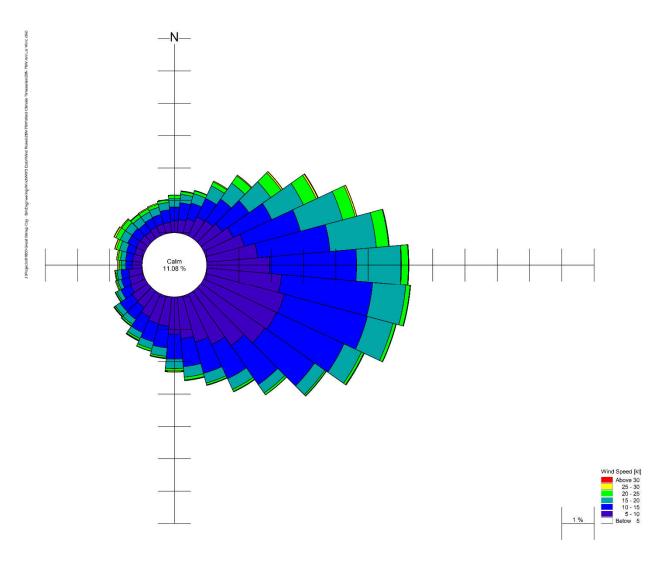
Figure 15: Annual wind rose plot for Great Stirrup Cay from 1979-2009

An analysis of the wind climate was conducted to understand the magnitude, direction, and any seasonal trends relating to the wind climate. Offshore wind data provided by NOAA during the period of January 1979 to December 2009 was extracted at grid point latitude 26 0'N and longitude 78 0'W, located approximately 20 kilometers north of the Project site. Specifically, the data is from NCEP Climate Forecast System Reanalysis and Reforecast (CFSRR) dataset, which was validated using archived wind observations. The acquired data from the hindcast includes a time series of approximately 31 years of wind information at 3-hour intervals. A statistical analysis was conducted and percentage occurrences for various directions and wind speeds are summarized in (Figure 15) as a wind rose. A wind rose is a bar plot with angles representing the directions, bar length representing the percentage occurrences to scale, and the colors representing the magnitude (i.e. wind speeds).

Based on the statistical analysis and developed wind rose winds are predominantly from the east and southeast with some seasonal variation. The wind speed is less than 10 knots 45% of the time, and the wind speed is below 20 knots 94% of the time. The seasonal changes in wind speed and direction were evaluated. One of the trends observed is the winds in the winter months are stronger than those in the summer, with the exception of hurricane events. Additionally, the winds in the winter months not only include easterly winds, but also northern and northwesterly winds with relatively high magnitudes. The northeasterly and northern winds are typically associated with winter fronts approaching from the west and are typically accompanied with inclement weather.

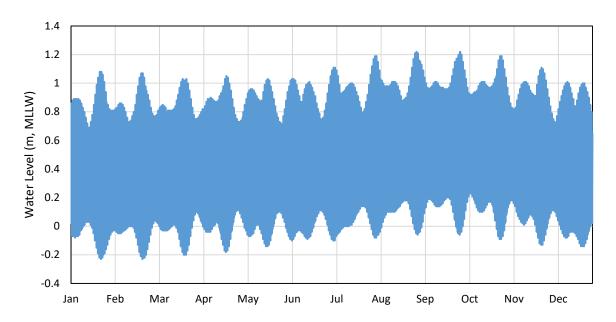
Figure 16: 2019 annual predicted tides at NOAA station 9710441, Settlement Point, The Bahamas

Tides in the Project vicinity are predominately semi-diurnal with a mean tide range of approximately 0.8 m (2.7 ft) and a period of approximately 12.4 hours. Tidal data was obtained from National Oceanographic Atmospheric Administration (NOAA) Station 9710441 at Settlement Point at Grand Bahamas Island (**Table 6**). As illustrated by **Figure 16**, there is a great variability in the tidal range on both a monthly and annual basis with a range from 0.9 m (3.0 feet) to 1.2 m (4.0 feet).

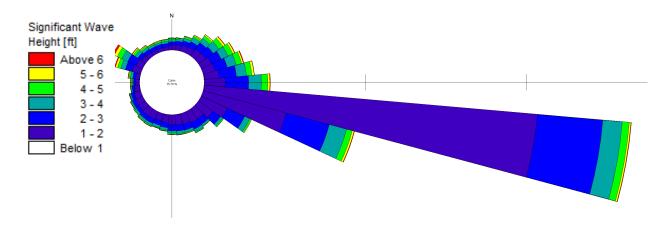
Figure 17: Annual wave rose plot for GSC

An analysis of the wave climate was conducted to understand the magnitude, direction, and any seasonal trends relating to the wave climate. Offshore wave data provided by NOAA during the period of January 1979 to December 2009 was extracted at grid point latitude 26°N and longitude 78°W located approximately 13 miles northwest of the Project site. A statistical analysis was conducted and percentage occurrences for various directions and wave heights are summarized in **Figure 17** as a wave rose.

Based on the statistical analysis and developed rose plot, waves are predominantly from the southeast with some seasonal variation. The wave heights are less than 2 ft 60% of the time, and less than 3 ft 80% of the time. The waves in the winter months travel from the northwesterly direction which are generally higher in magnitude, while during the summer months the waves are low in magnitude and approach primarily from the southeast.

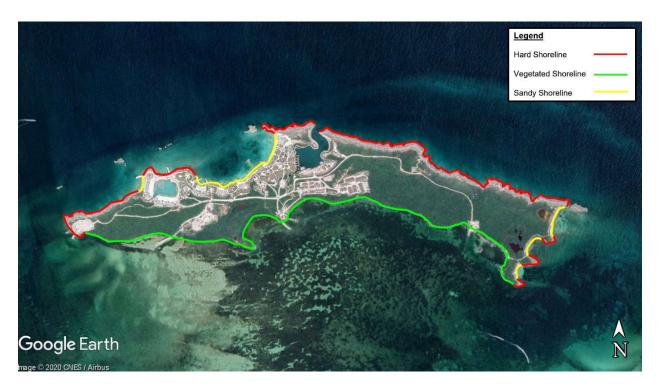
Figure 18: GSC shoreline classifications

The island's shorelines have been classified into three types: hard, soft, and vegetated. The shoreline assignment is presented in **Figure 18**. As observed in **Figure 18**, the eastern northern half of the island is characterized by a hard shoreline, specifically an ironshore bluff exposed to relatively large offshore waves. Limited sediment transport occurs in the northeastern half of the island due to the limited sediment supply and deeper water depths.

On the eastern-facing portion of the island, three pocket beaches are observed. Here the sediment transport is primarily wave driven, as the pocket beaches are oriented perpendicular to the predominant incoming wave direction. The southern portion of the island is characterized by a vegetated shoreline. Limited sediment transport occurs in this region due to the presence of high-density seagrass and shallow water depths, which result limited wave energy. The sediment transport in the sandy area in the northern portion of the island is mainly wave-driven. In this location the beaches are anchored by coastal structures (groins and breakwaters), which limit the longshore sediment transport and thus stabilizing the beaches.

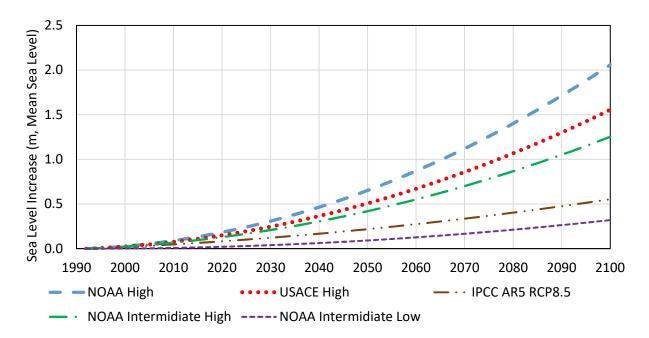
Figure 19: Sea level rise projections

Many projections for SLR have been published, but no single projection is accepted as the standard to be utilized for future water levels. For the purpose of the present analysis at Great Stirrup Cay, a comparison of 5 published SLR projections was conducted. The projections were: NOAA High, NOAA Intermediate High, NOAA Intermediate Low, USACE High, and the Intergovernmental Panel on Climate Change Fifth Assessment Report Representation Concentration Pathway 8.5 Median Curve (IPCC AR5 RCP8.5 Median). To adapt the projections for regional use in the area of Florida and The Bahamas, the average rate of mean SLR was adjusted from a global value of 0.0017 m/yr to a local value of 0.0022 m/yr as observed in the Key West tide gauge. **Figure 19** displays the sea level increase over time for the different projections. As

observed in **Figure 19**, the difference between projections for the SLR increase over time, illustrating the uncertainty in future water levels.

Depending on the type of infrastructure and the risk associated with damages due to SLR impacts, the use of a different projection may be more appropriate. As an example, the design of a critical infrastructure element such as a nuclear plant where failure could be catastrophic, the use of the highest projection curve (NOAA High) may be more appropriate to reduce the risk of impacts due to SLR. For a structure that is easily replaceable, low cost, low service life, and whose failure does not pose a hazard, the use of the lowest projection curve may be more appropriate. Another consideration in the use of the projections is the incremental cost of selecting one projection over another. Depending on the type of infrastructure being constructed, the incremental cost to select a higher projection may be either minimal or economically unfeasible. For a general analysis of the impacts of SLR on extreme conditions at the Project site, the following assumptions were made: design life of 50 years, and the structure is difficult or costly to replace, but damage not catastrophic to the Project site. Based on these assumptions, the NOAA Intermediate High projection curve was adopted for subsequent analysis.

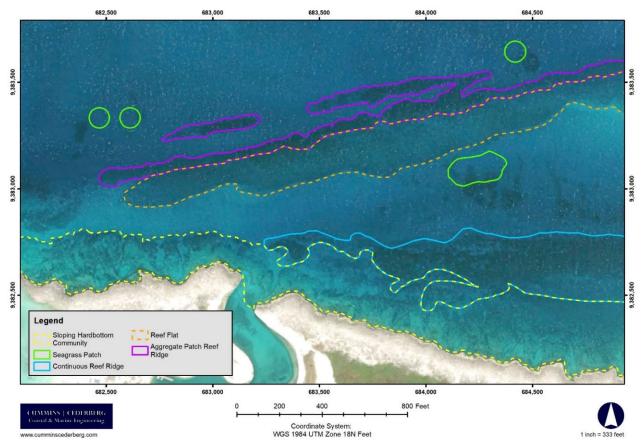
Figure 20: Coral reef, hardbottom, and seagrass habitats within the Project area

Four distinct reef habitat types (**Figure 20Figure 20**: Coral reef, hardbottom, and seagrass habitats within the Project area) were documented and mapped within the submerged Project area surrounding GSC. They included sloping hardbottom, continuous reef ridge, reef flat, and aggregated patch reef ridge communities. Living hard coral was greatest along the aggregate patch reef and continuous reef ridge with a mean percent cover of 12%, and 11%, respectively. Both the reef flat and sloping hardbottom had a

Seagrasses and associated macroalgae were documented as mixed SAV with varying coverage. **Figure 20** shows mapped seagrass communities within the Project area. A mix of *Syringodium filiforme, Halodule wrightii, Thalassia testudinum,* and numerous species of macroalgae (**Photo 5** and **Photo 6**) were found along the central portion of the survey area between the continuous reef ridge and reef flat communities.

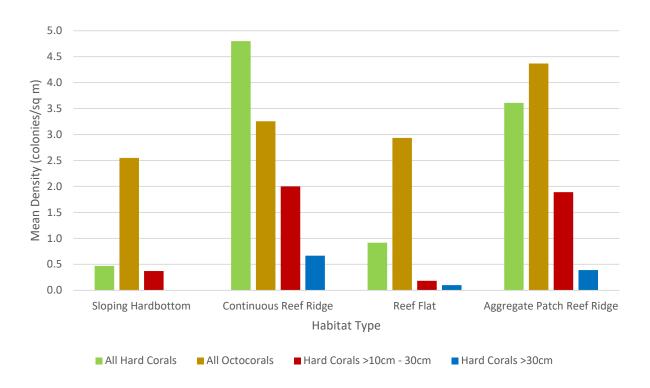
Figure 22: Mean hard coral and octocoral density data by habitat type and size category (hard corals only)

lower live hard coral cover of 4% and 1% and high coverage of sand and/or hardbottom (uncolonized substrate). By habitat type, the contiguous reef ridge and aggregate reef flat have the greatest mean hard coral densities at 4.8 and 3.6 colonies/sq m, respectively, with the larger colonies (10 to 30 cm [Photo 1 and Photo 2]; density 2.0/sq m) and largest (>30 cm [Photo 3 and Photo 4]; 0.7/sq m) on the contiguous reef ridge. Figure 21 and Figure 22 provide the percentage of substrata (and living coral) and mean density data by their respective habitat categories. The full benthic survey report is provided in Appendix A, including comprehensive species lists of all corals and octocorals observed.

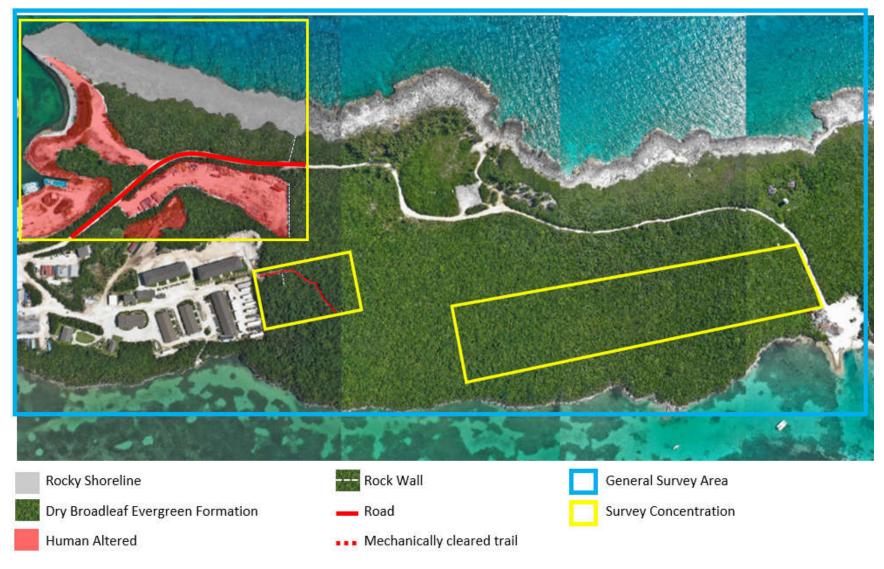
Figure 23: General survey area and habitat types

The surveyed areas consisted of a section of coastline and interior upland areas. Three (3) vegetation type classes were encountered within the survey limits - rocky shore, dry broadleaf evergreen formation (DBEF) and human altered, as described below. **Figure 23** shows the general survey area, areas of concentration, and vegetation types. Upland vegetation was either all DBEF or human disturbed areas that were previously DBEF.

The interior DBEF forest in the southern portion of the survey area (**Figure 23**), where portions of the forest are proposed for use as a confined upland disposal area differ slightly in vegetation height. The dredge spoil site has a slightly wind-pruned canopy (**Photo 15**) with an average height of fifteen (15) feet while the back of staff housing has an average height of fifteen to twenty (15-20) feet. There is a recently mechanically cleared trail and rock wall in the back of staff housing area within DBEF (**Photo 16-19**).

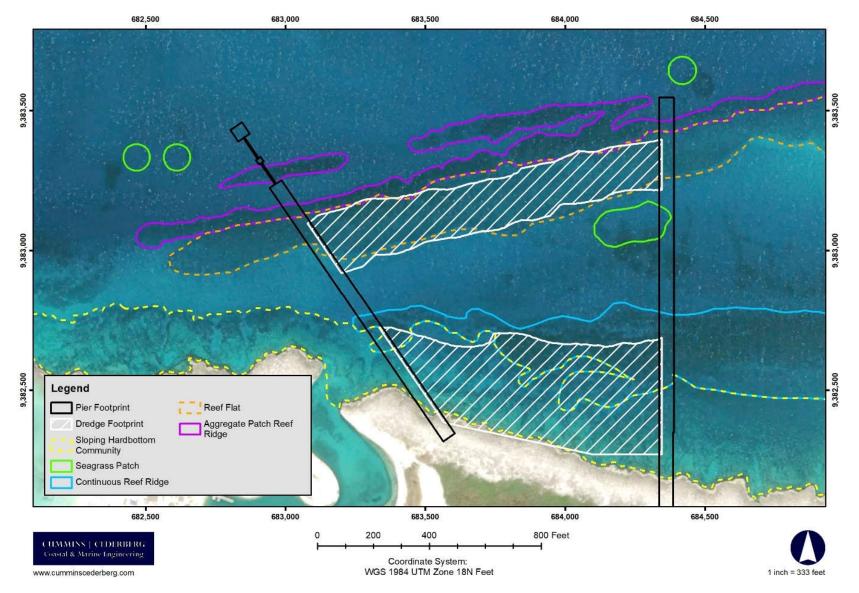
Figure 24: Pier and dredge footprint over habitat areas

Drawings of the pier and proposed dredge footprint were overlain on the marine resource habitat maps as shown in (**Figure 24**). The total proposed dredge footprint covers an area of ~12.7 acres across the hardbottom and reef habitats but does not intersect any of the mapped seagrass areas. The total areas of the West and East Piers cover ~3.1 acres across each of the four primary habitat types. The East Pier footprint also intersects an area of seagrass centrally located between the continuous reef ridge and the reef flat habitats. **Table 15** provides the areas of the proposed pier and dredge footprints.

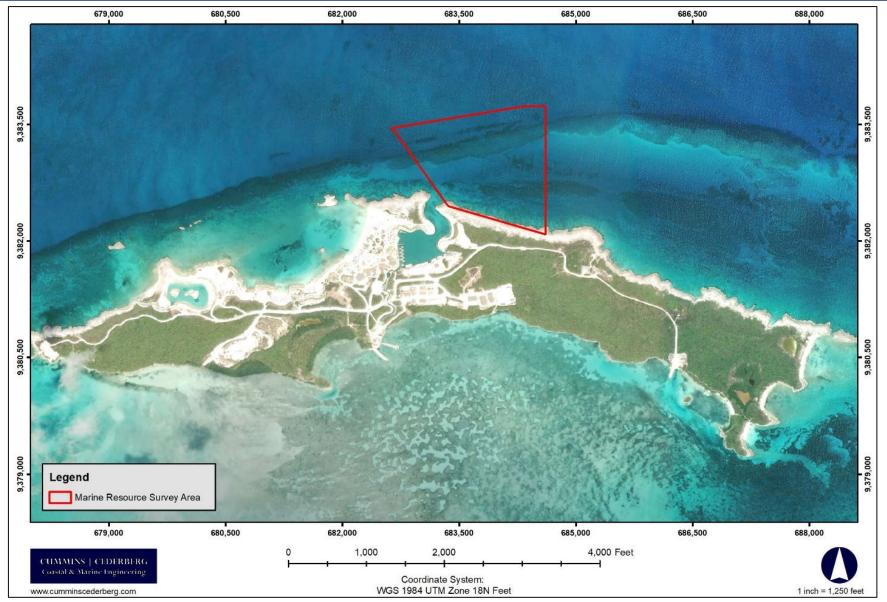
FIGURE 1 - APPROXIMATE MARINE RESOURCE SURVEY AREA

The current survey was designed to assess the density of hard corals (Scleractinian) and soft corals (octocorals), determine the condition and quantity of submerged aquatic vegetation, map the habitat transitions from the shoreline waterward, and document the presence of other marine resources. Additionally, fish and invertebrate species observed during the survey were noted to create a qualitative list of notable species within the survey area.

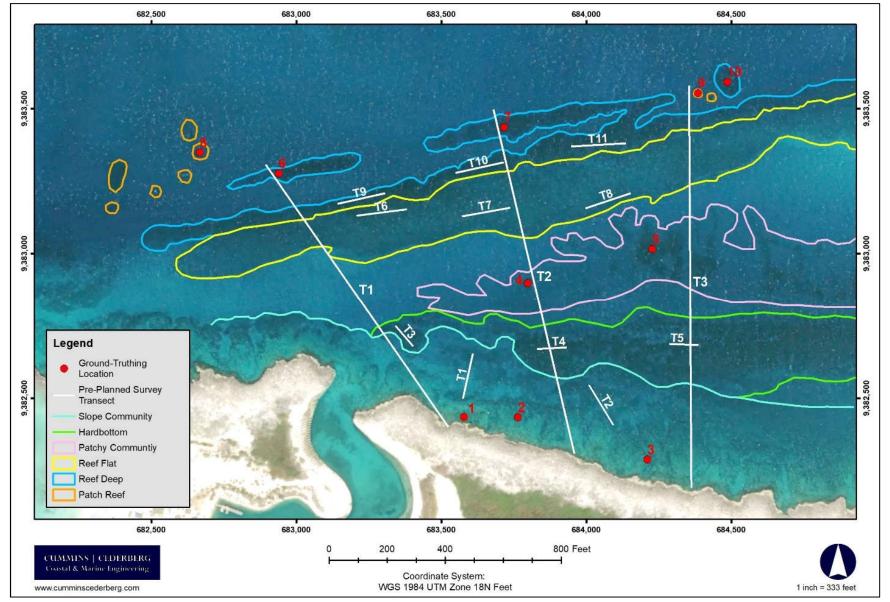
FIGURE 2 - PRE-PLANNED SURVEY TRANSECTS, GROUND TRUTHING POINTS, AND ANTICIPATED HABITAT TYPES

Video data was collected at an approximate 45° angle along the entirety of each transect. A slate or clipboard with the project name, date, reef zone, and site number were recorded at the beginning of the video segment followed by a panoramic view of the start of the transect. A diver swam the length of the transect line and recorded video at an oblique angle approximately 40 cm from the seafloor. At the end of the transect line, another panoramic shot was taken before turning off the camera.

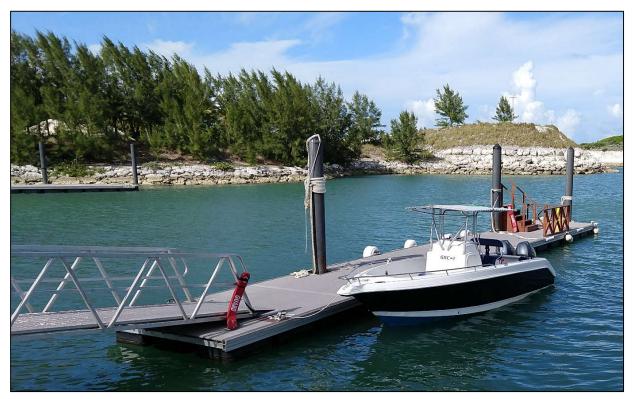
PHOTO 1 – SURVEY VESSEL STAGED AT THE NORTH HARBOUR DOCKS

The field survey and data collection were performed 18 - 22 July 2020 from a support vessel (**Photo 1**) by experienced marine biologists (**Photo 2**) and a HYPACK operator/navigator. Due to extensive resources (i.e. hard and soft corals) within the area, the coral belt-transect field methodology was altered slightly during surveying to accommodate the completion of all transects and points. Belt-transect data was collected for shorter distances along the transect lines (between 10 and 35 meters), rather than the full length of the transect line (30 to 50 m); video and point-intercept data were still collected the entire length of the transect lines.

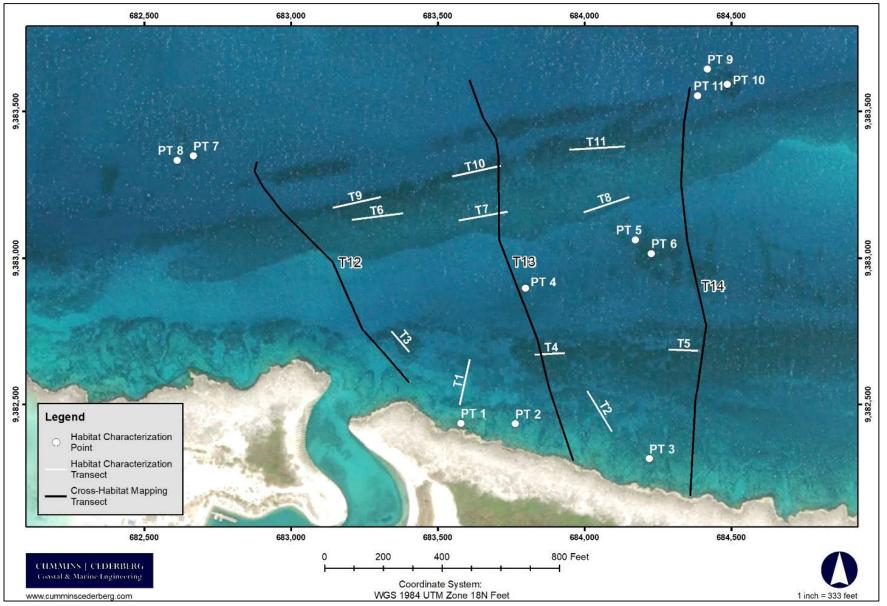
FIGURE 3 - TRANSECT AND POINT LOCATIONS COMPLETED DURING BENTHIC HABITAT SURVEY

Transect and ground-truthing point locations were also adjusted to represent accurate field locations. As shown in Figure 3, a total of fourteen (14) transects (T1 – T14) were surveyed, including eleven (11) characterization transects (T1 – T11) and three (3) mapping transects (T12 – T14). Additionally, a total of eleven (11) ground-truthing points were surveyed. In addition to transect surveys, biologists collected representative photographs (**Appendix A**) and compiled a list of all species observed (**Appendix B**), including all hard and soft coral colonies, submerged aquatic vegetation, macroinvertebrates and fish. A total of twenty-seven (27) species of hard corals and fourteen (14) genera of octocorals were documented (**Appendix B**), with numerous coral colony specimens exceeding 1-m in either width, height, or both (**Photos A-7**, **A-9**, and **A-13**).

Using the overlay of the transects locations (**Figure 3**) on the overall habitat map (**Figure 4**), data from the transects that fell into the four habitat types (sloping hardbottom, continuous ridge reef, reef flat, and aggregate patch reef ridge) were analyzed collectively to get a holistic picture of percent cover of the substrata by habitat type. **Table 5** and **Figure 6** present the overall percentages for each habitat. Living hard coral was greatest along the aggregate patch reef and continuous reef ridge, with a mean percent cover of 12%, and 11% respectively. Both the reef flat and sloping hardbottom had lower live hard coral cover of 4% and 1%, and high coverage of sand and/or hardbottom (uncolonized substrate). Octocoral coverage was less than 10% in all habitats, although this may be a bit misleading because surface area for these organisms is greatest above the substrate where the plumage is within the water column, whereas for other organisms such as hard corals and sponges that spread both horizontally and vertically from the substrate.

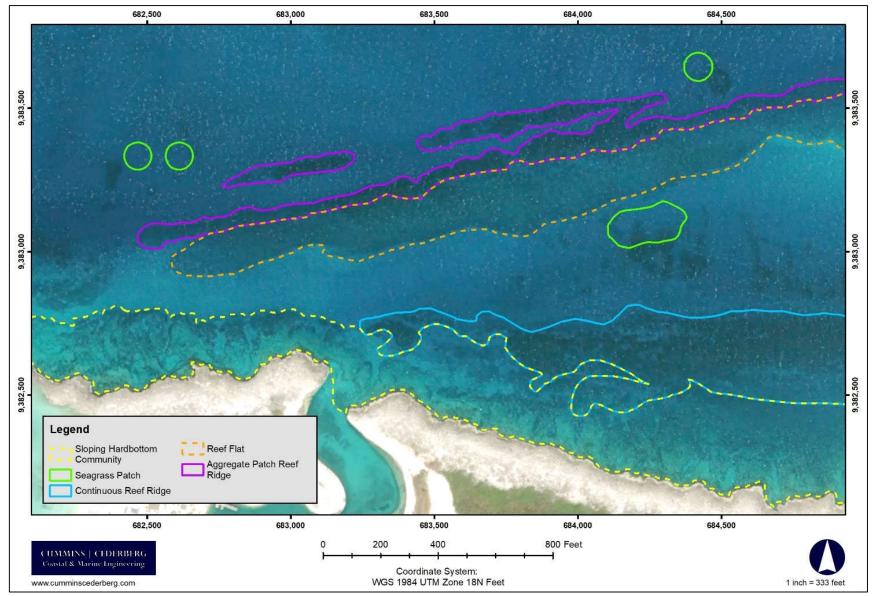
FIGURE 4 - BENTHIC HABITAT TYPES WITHIN SURVEY AREA

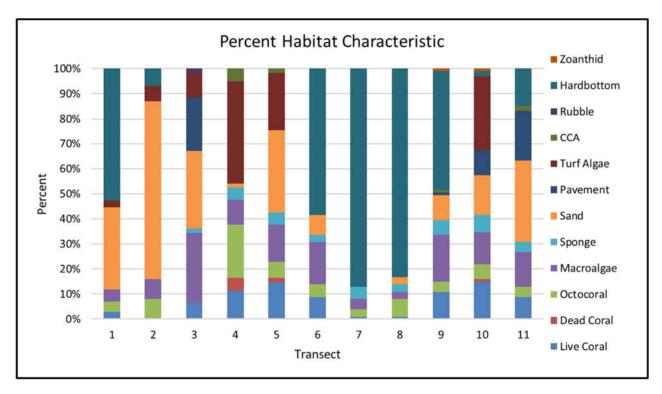
FIGURE 5 - PERCENT COVER OF HABITAT SUBSTRATA BY TRANSECT NUMBER

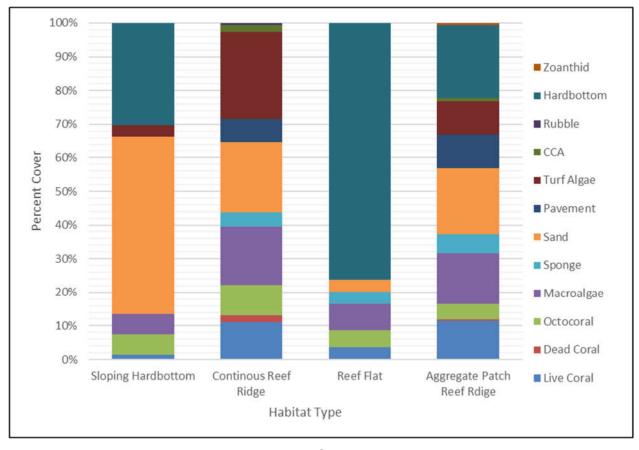
FIGURE 6 - PERCENTAGE OF SUBSTRATA BY HABITAT TYPE

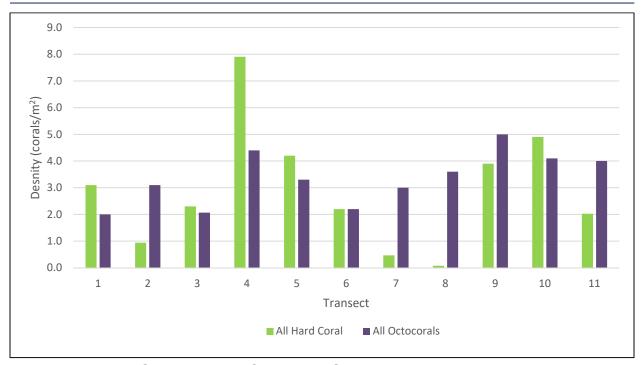
FIGURE 7 – OVERALL HARD CORAL AND OCTOCORAL DENSITIES BY TRANSECT

**Table 6.** and **Figure 7** and **Figure 8** show hard coral densities by transect and by size categories of hard coral colonies. Density estimates are greatest for all coral colonies along T4 and T10, at 7.9 colonies/m² and 4.9 colonies/m². Larger hard coral colonies between 10 cm and 30 cm were most prevalent along T5 and T10, with the largest hard coral colonies (>30 cm) recorded along T4 with 1.3 hard coral colonies >30cm per m².

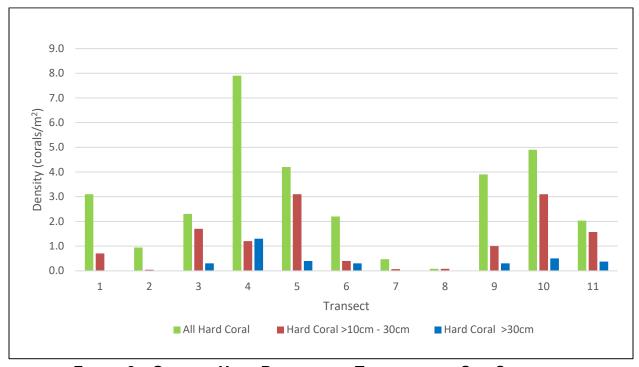
FIGURE 8 – OVERALL HARD DENSITIES BY TRANSECT AND SIZE CATEGORY

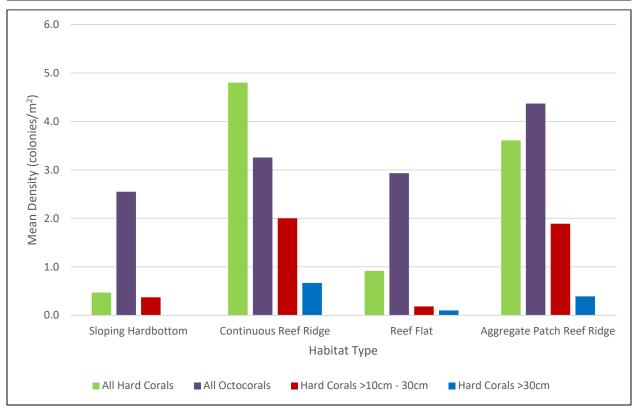
FIGURE 9- MEAN HARD CORAL AND OCTOCORAL DENSITY BY HABITAT TYPE AND SIZE

CATEGORY (HARD CORALS ONLY)

By habitat type, the contiguous reef ridge and aggregate reef flat have the greatest mean hard coral densities at 4.8 and 3.6 colonies/m², respectively, with the larger colonies (10 to 30 cm; density 2.0/m²) and largest (>30cm; 0.7/m²) on the contiguous reef ridge. **Table 7** and **Figure 9** provide the density data by transect within their respective habitat categories, and the mean densities within each habitat.

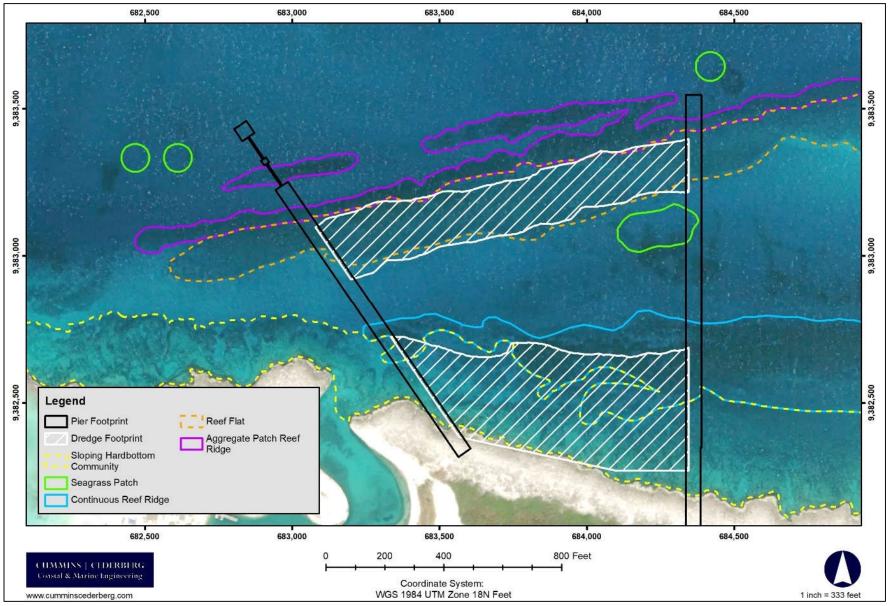
FIGURE 10 - PIER AND DREDGE FOOTPRINT OVER HABITAT AREAS

Drawings of the pier and proposed dredge footprint were overlain on the marine resource habitat maps as shown in **Figure 10**. The total proposed dredge footprint covers an area of 544,846 ft<sup>2</sup> (50,618 m<sup>2</sup>) across the hardbottom and reef habitats but does not intersect any of the mapped seagrass areas. The total areas of the west and east piers cover 136,436 ft<sup>2</sup> (12,675 m<sup>2</sup>) across each of the four primary habitat types. The east pier footprint also intersects an area of seagrass, centrally located between the continuous reef ridge and the reef flat habitats. **Table 8** provides the areas of the proposed pier and dredge footprints.

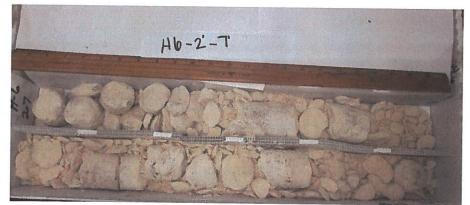
Figure 4. Boring 6 Limestone 2'-7'

Borings B1, B9, B10, B11, B12, B13 and B14 completed in other areas of the island present limestone under one to two feet of sand. Pictures of the cores taken from the limestone formation at different depths are shown in the Figures 4 through 7 below. Notice the low recovery of the samples from 2 to 7 feet presented in Figure 4 that corresponds to boring B6. This limestone, if sampled with the SPT spoon could be recovered as sand.

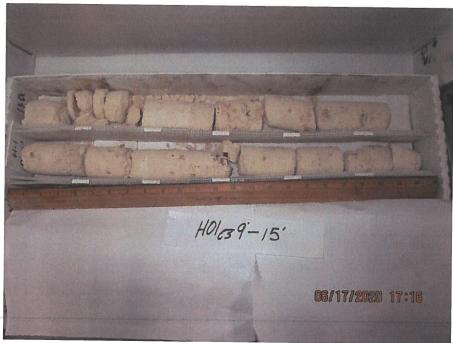
Figure 5. Boring 9 Limestone 10'-13'

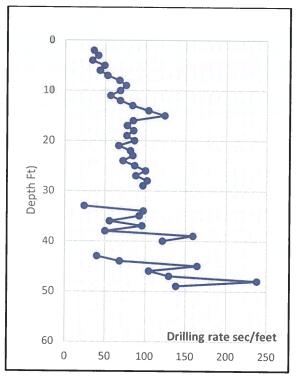
Figure 8 presents the average drilling rate during core retrieval. The drilling rate provides a continuous assessment of the rock strength represented by the time it takes to drill one foot at a boring location. Notice that across the island hard limestone layers were found between 13 and 15 feet and 38 feet and 50 feet below grade.

Figure 8. Average drilling rate for all the core borings.

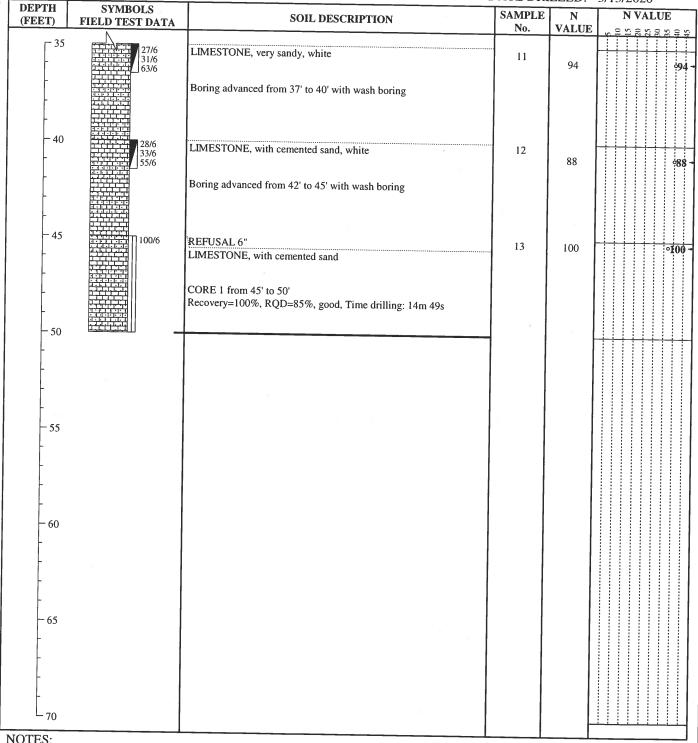
FIELD TEST DATA ARE "BLOWS"/"INCHES DRIVEN". 140-LB HAMMER, 30-INCH FALL. (ASTM D-1586)

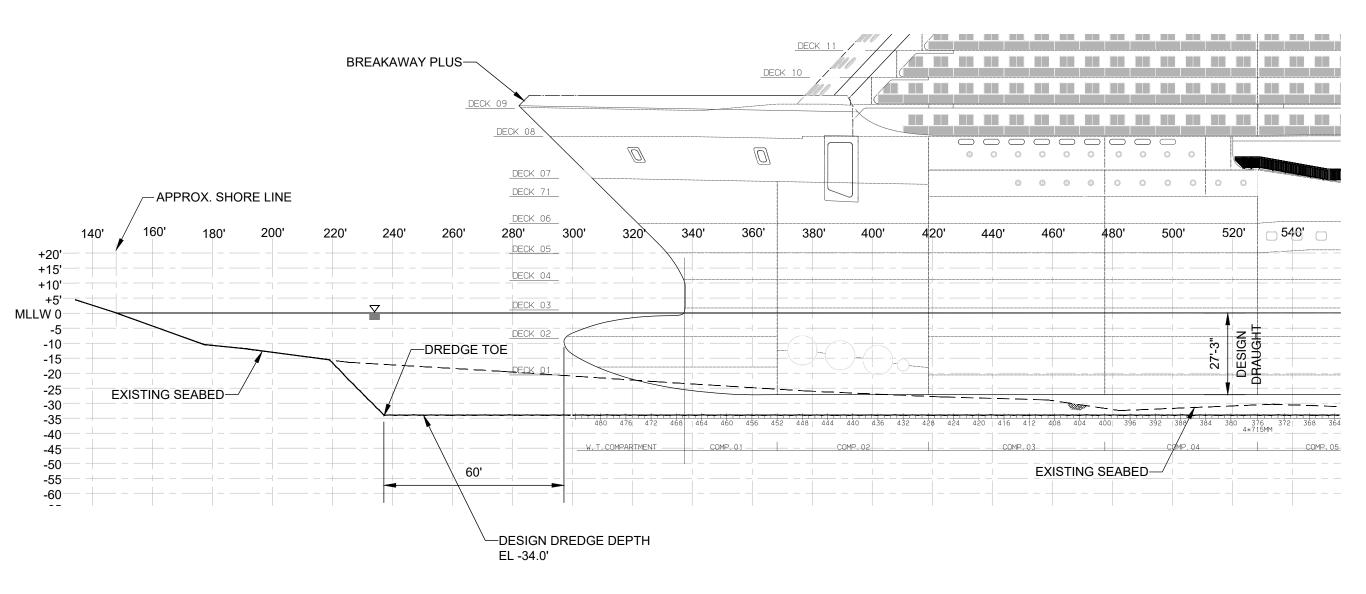
SHEET 3 OF 10

**EAST PIER** DREDGE SECTION **PROFILE** DRAWING #:

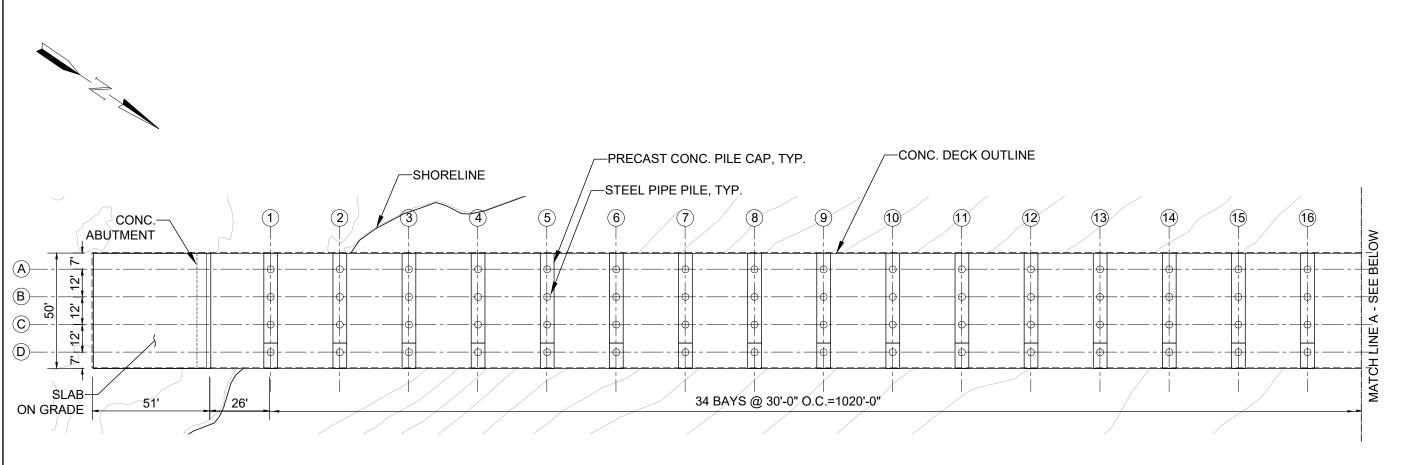
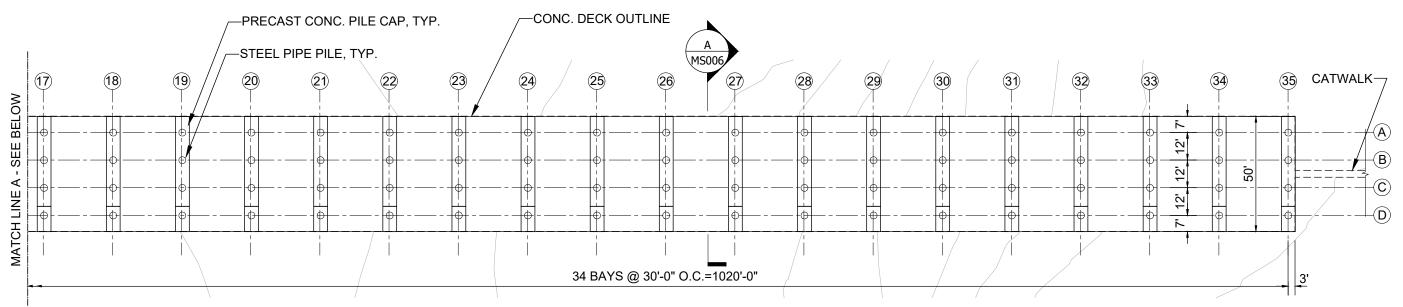
WEST PIER - PILE AND CAP PLAN

SCALE: 1=500
