**Public Buildings Sector  
Weekly Summary (21)  
July 6, 1700 AST**

# Build Back Better: Reimagining and Strengthening the Power Grid of Puerto Rico

December 2017

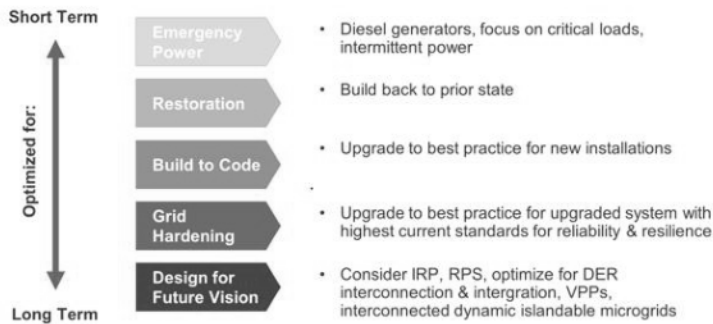
**FIGURE E-1. POWER AND GRID REBUILD APPROACH**

Site-by-site engineering studies are required to further catalog all damage, verify weakened infrastructure in need of hardening, and document abnormal conditions to develop site and device specific requirements and next-level cost analysis for the rebuild effort.

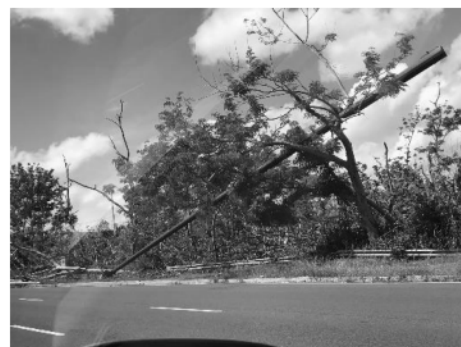
Damaged Poles

The storm ultimately impacted most of the island with a combination of high winds and flooding. Other severely impacted areas included the northern coast, as the rotation of the hurricane caused coastal surge to meet major rain runoff from the mountains, leading to sustained flooding. Transmission lines in the center of the island were severely impacted, as high winds were funneled through the changes in terrain and tore down large transmission lattice towers.

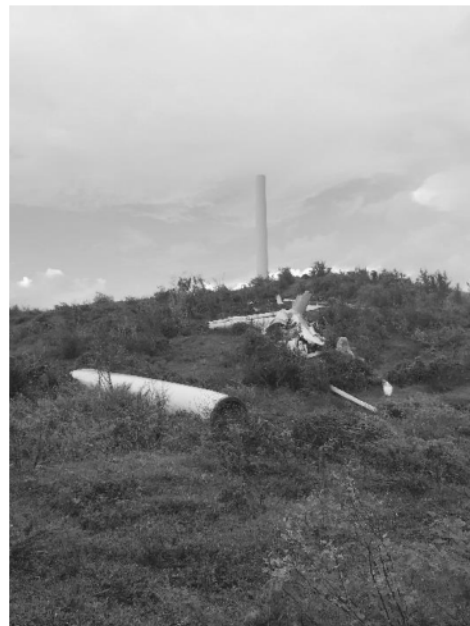
Destroyed Wind Generation

The hurricanes decimated T&D lines across the island and caused widespread wind and flooding damage to substations, generation, and distribution facilities. Damage from the hurricanes resulted in the longest duration power outage in US history. This cataclysmic failure of the power grid provides a unique opportunity to rebuild and update the power system to 21<sup>st</sup> century technologies and best practices, enabling the rethinking of how power is generated and distributed to customers across Puerto Rico.

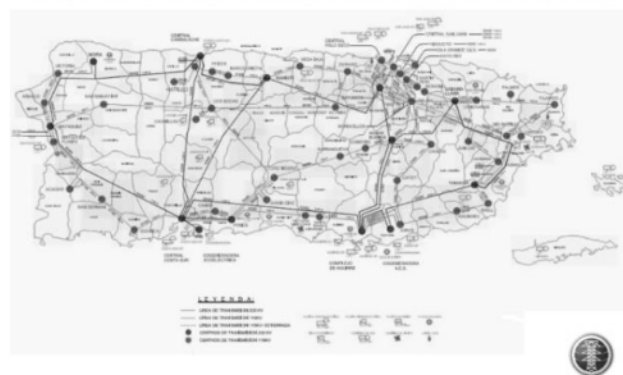
FIGURE 3-1. PREPA TRANSMISSION SYSTEM

#### 230 & 115kV TRANSMISSION SYSTEM

The 230 kV system has two north to south corridors which divide the system into three principal loops: 1) the western loop; 2) the central loop; and 3) the eastern loop. The western loop connects the Costa Sur and EcoElectrica generators in the south with the Mayaguez switchyard and generation on the west coast, and then continues to the northern cities of Aguadilla, Hatillo, and Arecibo. The center loop connects generators in the south to the San Juan area via Aguas Buenas TC south of the city. A parallel 230 kV line in the island center connects the Costa Sur and EcoElectrica generators from the south with San Juan and the Cambalache combustion turbine on the north coast. The central loop is joined by east-west transmission lines connecting the Costa Sur units with the Aguirre plant in the south, and a line in the north connects Manati to Aguas Buenas via Bayamon. The eastern loop connects large generating units in the south (Aguirre units in Salinas and the AES plant in Guayama) to the eastern part of the island through Yabucoa and Rio Blanco, terminating in Sabana Llana, southeast of San Juan.<sup>13</sup>

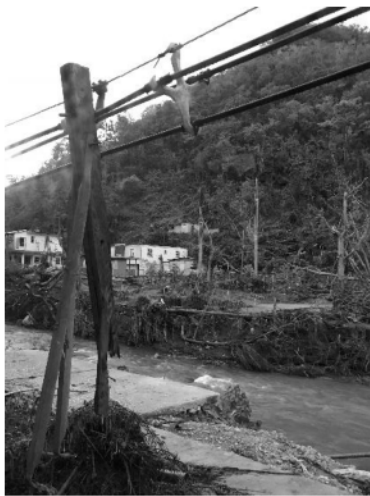
Source: NYPA/Con Edison Damage Assessments

Many of these lines were built more than 50 years ago, prior to the construction of the major highways crossing the island, and most are in difficult-to-reach locations, with no right-of-ways separating transmission towers and lines from trees or other structures. Due to protected plant and wildlife, the right-of-ways cannot be expanded or properly maintained in their current locations. The Working Group proposes that new transmission lines be installed along major highways throughout the island.

Major highways have established right-of-ways and should limit the environmental impact while reducing the time needed to obtain permits. The rebuild costs will also be lower along the highways because they are easily accessible by road.

Notably, the southeast area of the island is particularly vulnerable to hurricanes, as the most destructive storms typically sweep through this part of the Caribbean on a northwest trajectory. Where possible, relocated transmission lines along highways in this area should be further hardened via shorter spans and greater separation between phases and grounded structures. In addition, these transmission lines should have hardened lightning protection because the island is susceptible to severe lightning. Also, the prospective system should be designed to ensure the system can

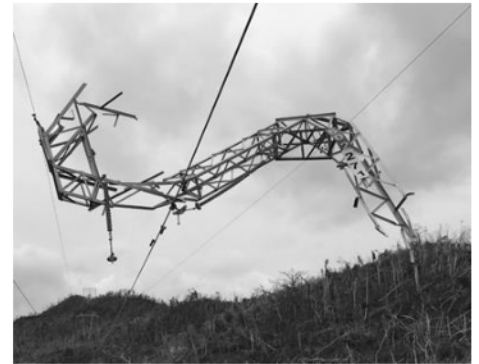
Source: NYPA/Con Edison Damage Assessments

Damage information for this report was provided by select on-the-ground assessments by the NYPA and Con Edison teams as well as periodic reports from PREPA. While this information is adequate for developing initial recommendations, several planning and engineering studies are necessary to refine the proposed changes and proceed with project design.

Many of PREPA's transmission lines damaged during the storms were constructed decades ago, located in difficult-to-access areas where nearby highways now exist. PREPA reported that only 15% of the transmission lines are built to a mid-Category 4 criteria and the remaining 85% are built to lesser standards. A key example is the north-south corridor, where damage was extensive, and steep hills and muddy slopes have made access difficult, leading to long repair times. Many transmission corridors, including the North-South line are heavily treed with narrow rights-of-ways. Widening of these corridors is limited due to environmental restrictions to accommodate protected wildlife and vegetation.

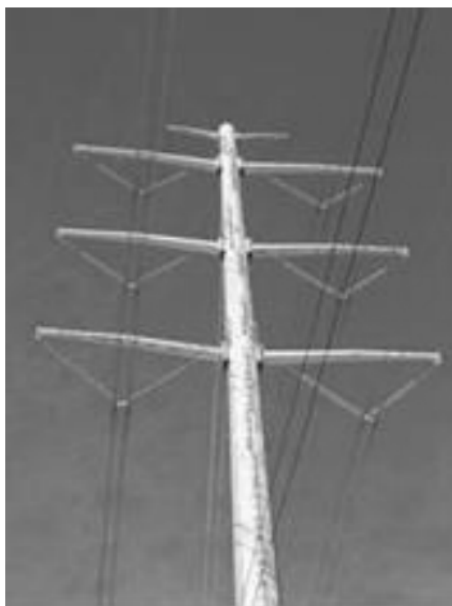
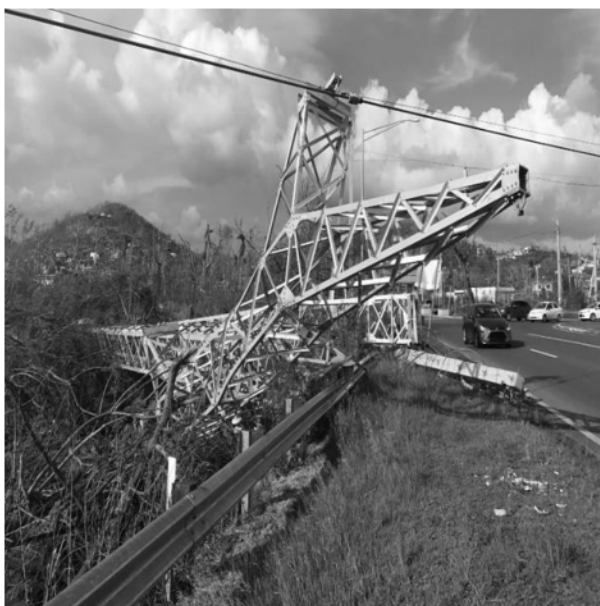
Monopole designs generally performed better than lattice tower designs.

The Working Group recommends relocating and upgrading up to 350 miles of overhead transmission lines, with high strength insulators, structures, and conductor spacing designed to withstand stronger wind loading than the current design standard. At a minimum, structures located in areas prone to high winds should be reinforced to withstand Category 4 storms, including lines along the critical North-South corridor.<sup>15</sup> The Working Group also recommends that the transmission system be designed to enable integration of large renewables and smaller microgrids. This would serve to reduce PREPA's reliance on fossil fuel generation while providing greater resiliency to the island-wide grid.<sup>16</sup>

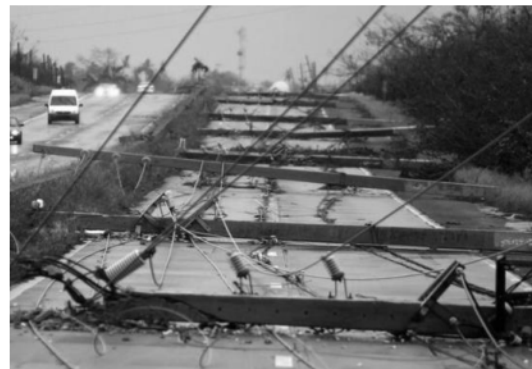
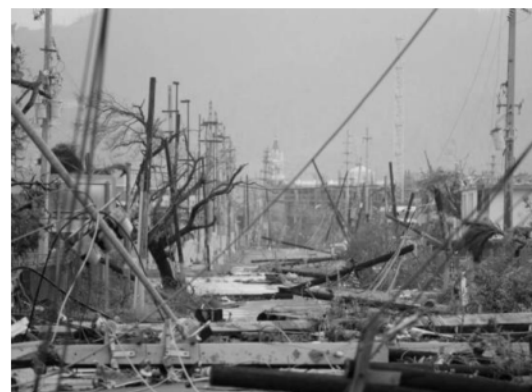
Concrete and wood poles both experienced severe damage, while galvanized steel fared better during the storm. Numerous substations located along distribution circuits that step down primary voltages to lower primary, or secondary voltages were also severely damaged. The photos below illustrate the severity of damage encountered on overhead lines, including destroyed concrete and wood distribution poles.

The distribution system encountered significant damage, with up to 75 percent of circuits needing repair. Both the overhead and underground systems were affected. Pre-storm distribution poles were not designed to withstand a Category 4 storm and underground equipment experienced water and contaminant intrusion. The limited use of dead-end breakaways on distribution poles led to a domino effect, with long sections of line failing successively.

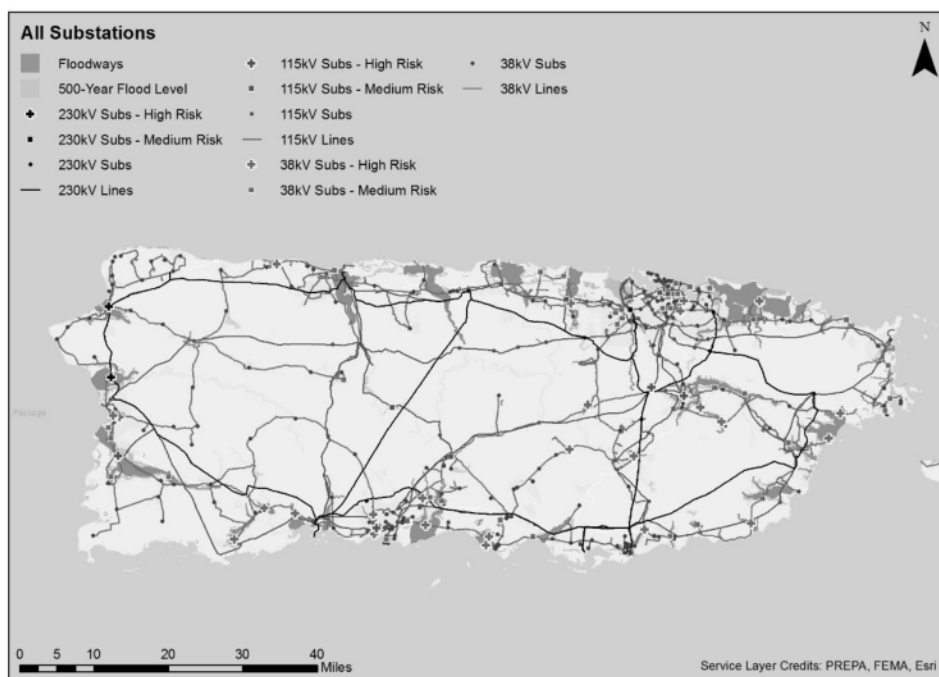
**Figure 3-3. GIS MAPPING - SUBSTATIONS AND FLOOD RISK AREAS IN PUERTO RICO**

mapping (Figure 3-3). Table 3-5 depicts the infrastructure per voltage class and the risk of flooding relative to the flood zone.

The analysis that was performed estimates that there are approximately 15 115 kV and 230 kV sites in potential flood zones. It is recommended that future flooding risk at these sites be mitigated through a defense-in-depth approach that was used by several utilities in the New York and New Jersey area after Hurricane Sandy. The analysis also estimates that there are approximately 68 38 kV substations at risk for flooding. However, in the case of 38 kV substations, there may not be enough space for this preferred alternative. Therefore, it is expected that a higher percentage of the 38 kV substations will require elevation of critical equipment.

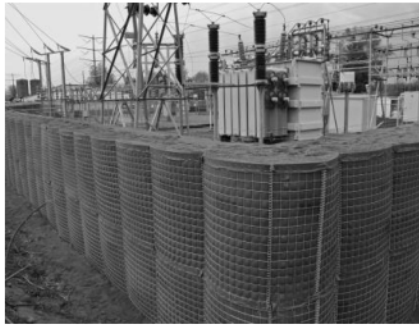
Flood Barrier  
Source: Con Edison

Several designs exist for accommodating roadway openings in the perimeter. While permanent water-tight

doors and earthen rises have been used in some cases in the industry, a less expensive approach would be to use light-weight aluminum tubes that can be dropped into pre-installed tracks and stacked to

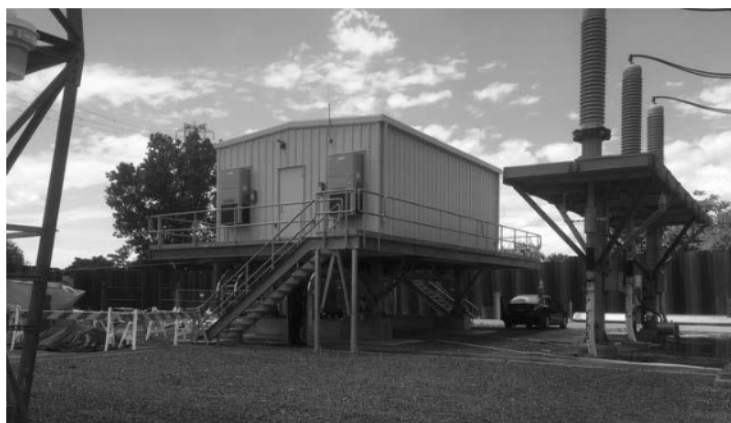
Modular Control Building

Also, for 38kV substations, the extent of damage in control cabinets, cubicles, and unit switchgear that were breached is difficult to quantify, even with detailed after-the-fact inspections.

PREPA also has a stated plan to convert the primary distribution system to 13.2 kV. Therefore, damaged

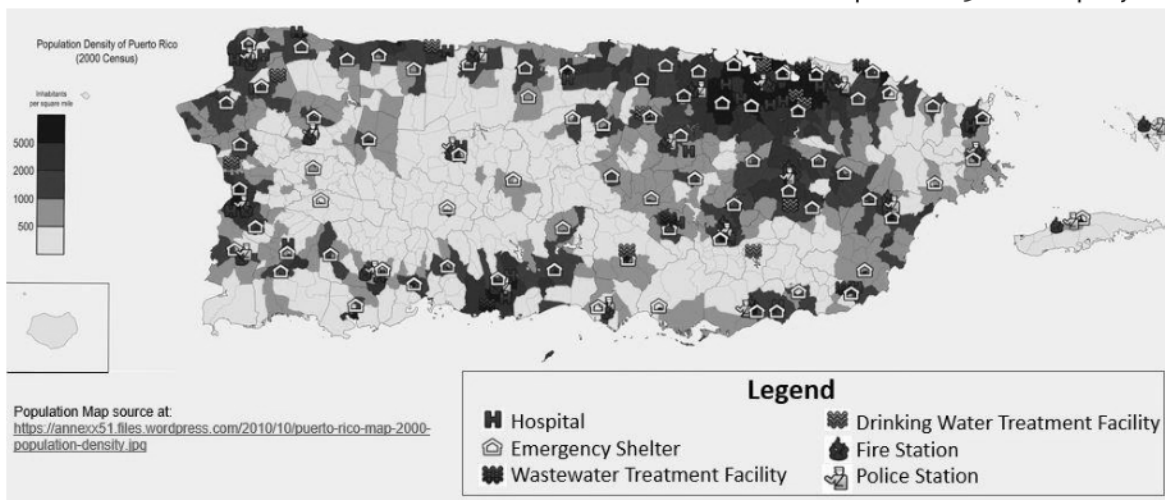
**FIGURE 3-4. HYPOTHETICAL ISLANDING OF CRITICAL INFRASTRUCTURE**

A map of potential critical infrastructure microgrid deployments is included below in Figure 3-4. The exact locations will require further study.

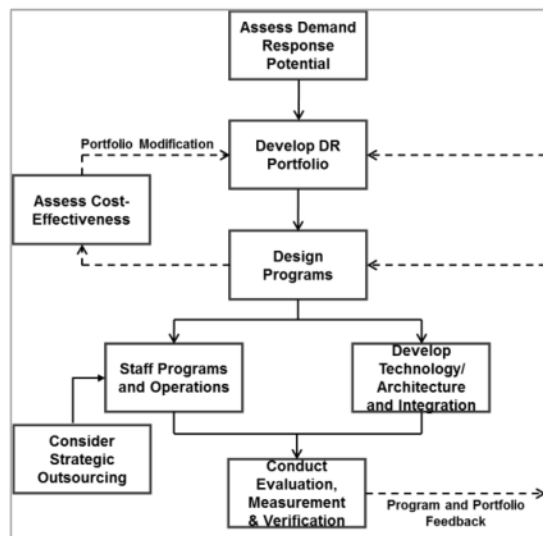
**FIGURE 3-5. RECOMMENDED APPROACH TO LAUNCH DR/ACTIVE DER PROGRAM**

- Smart thermostats
- Direct load control of thermostats or compressors
- Grid interactive water heaters
- Energy storage – this could be new builds or leveraging the storage deployed for microgrids as discussed above
- PV
- Electric vehicle charging modulation

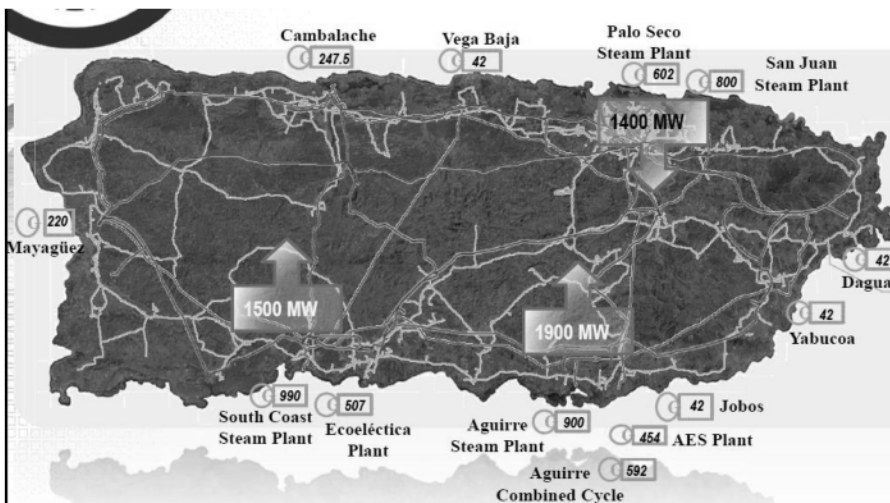
**FIGURE 4-1. PRIMARY GENERATION FACILITIES IN PUERTO RICO**

The primary generation facilities are shown in Figure 4-1. Nine of these sites have been identified in potential flood zones and are further described in the sections to follow. It is recommended that flooding risk at these sites be mitigated through a defense-in-depth approach as described in the Substations section of this report.

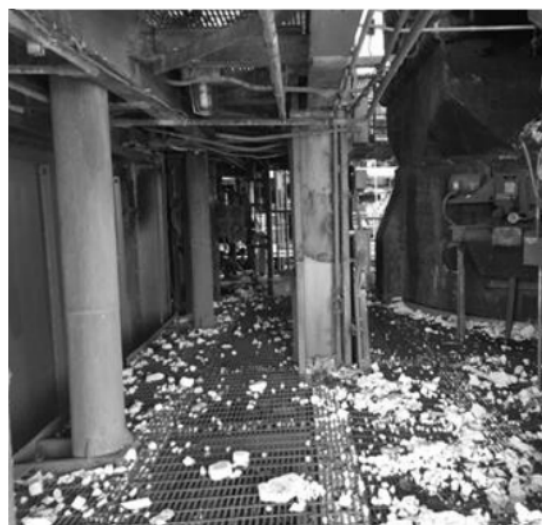
Source: NYPA/Con Edison Damage Assessments

While implementation of the recommendations in the 2015 IRP is proposed over multiple years, the conversion of some of the severely damaged plants to gas generation will be required in a much shorter timeframe.

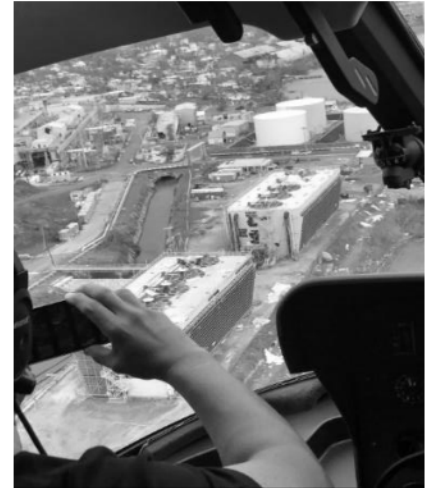
The plant experienced destruction of the cooling towers and an apparent bus failure on one of the combined cycle units. One of the combined cycle units was taken out of service prior to the hurricane. The steam units appear to have experienced minimal damage. A key issue is the lack of any available transmission lines leading to the switchyard. Depending on the results of the comprehensive inspection and testing, a significant portion of the units may be made functional quickly, but the lack of operating cooling towers will limit their full functionality. As of November 29, Aguirre 1 is in service.

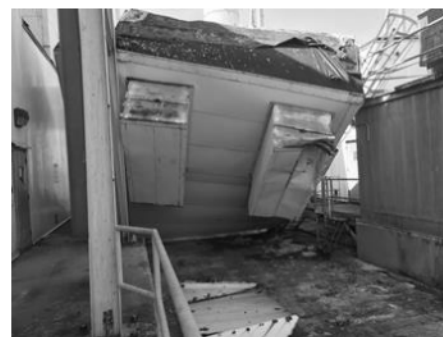
Source: NYPA/Con Edison Damage Assessments

Since the 2015 IRP does not anticipate any significant change in the station status, repairs to this station should proceed.

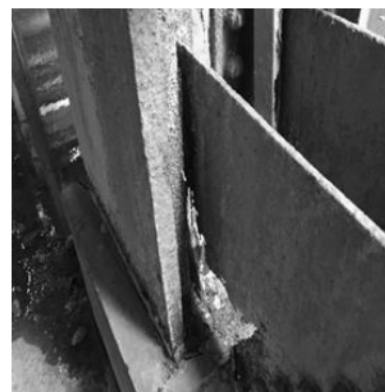
Source: NYPA/Con Edison Damage Assessments

With the extent of damage and significant safety concerns, the Working Group recommendation is to shut down or replace this facility.

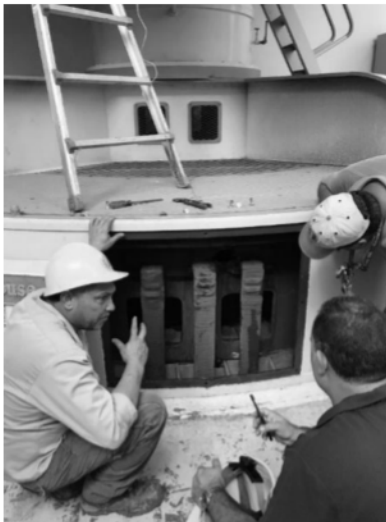
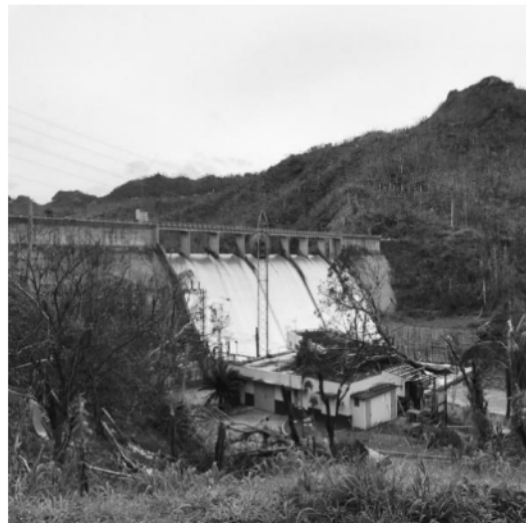
There was extensive damage to the Dos Bocas plant including intrusion of significant amounts of mud and water as well as damage to the Westinghouse unit due to a ground fault on the stator. Based on this assessment, the Working Group recommends a comprehensive evaluation of the facility including detailed inspection of all switchgear, rotating equipment and control systems. As of November 29, 2017, Yauco 2 and Toro Negro are in service.

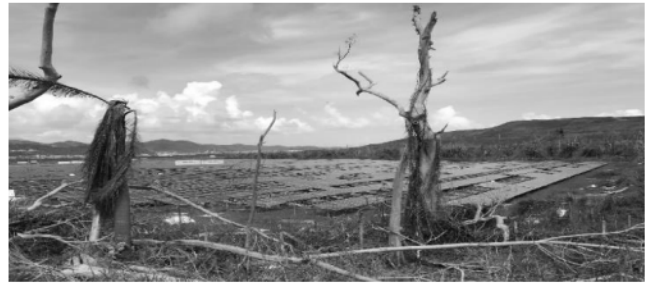
Source: NYPA/Con Edison Damage Assessments

For the privately-owned renewables, it is typical for the current owner/operators to be responsible for rebuilding the damaged facilities. The 2015 IRP anticipates up to 20% of the island's energy coming from renewables. Achieving this target will require investment in new<sup>38</sup> renewable sources of power and the rebuild of the existing facilities that suffered damage.

The estimated cost of repair of these merchant facilities is \$25 million for the wind farm and \$40 million for solar farm repairs. Repair/replacement of the existing solar and wind facilities is estimated to take approximately nine to 12 months.
