# Lake Otis Medical Clinic

### The Challenge

## Capstone C65 ICHP Microturbine

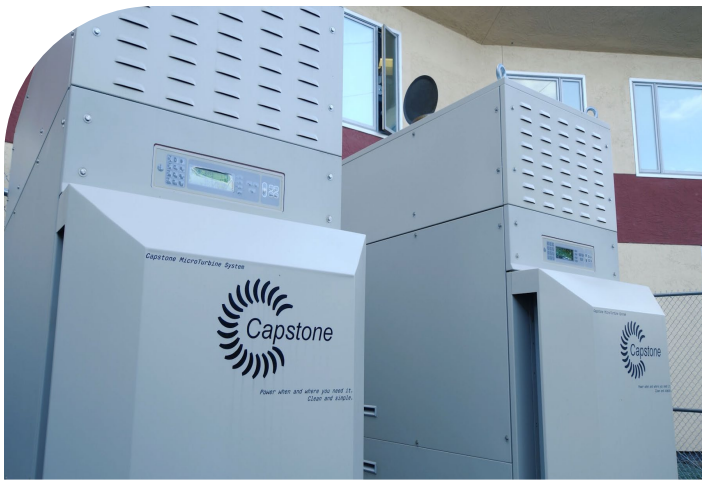
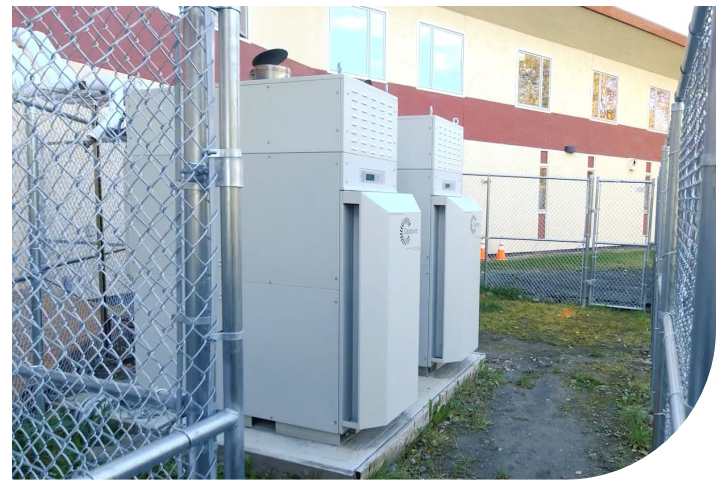
**Two C65 ICHP microturbines provide all of the medical facility's thermal and electrical needs, decreasing their carbon footprint by more than 70% and reducing noise pollution.**

In the upgraded system, hot water flows through an isolated loop to the facility's heat exchanger, the building's primary boiler. During winter months, when the facility is consuming all the heat and hot water it produces, the CHP system runs at efficiency between 85-90% efficiency—a major improvement.

The system runs in "dual-mode," parallel with the grid, so that in the event of a power outage, the microturbine system takes the entire load of the building. Once the grid comes back online and is stable for a minimum of five minutes, the system can re-connect to the grid.

Currently operating completely off the grid, the microturbines provide the entirety of the building's thermal and electrical energy needs, decreasing the carbon footprint by more than 70% and dramatically reducing the amount of indoor and outdoor noise pollution.

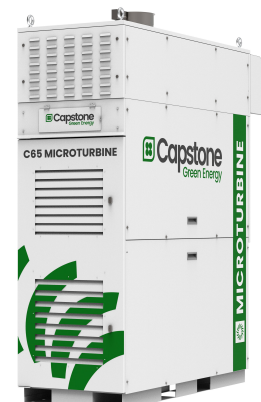
**A C65 provides up to 65kW of electrical power while the UL-Certified C65 ICHP provides up to an additional 150kW of thermal power for CHP and CCHP applications.**
