# Lake Otis Medical Clinic

## The Challenge

Located in the heart of Anchorage, Alaska, Lake Otis Medical Clinic is a 30,000-square-foot building that provides healthcare services to over 200 patients per day.

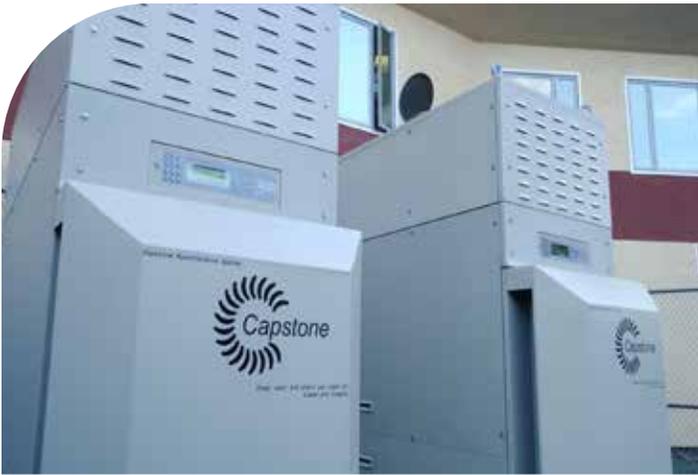
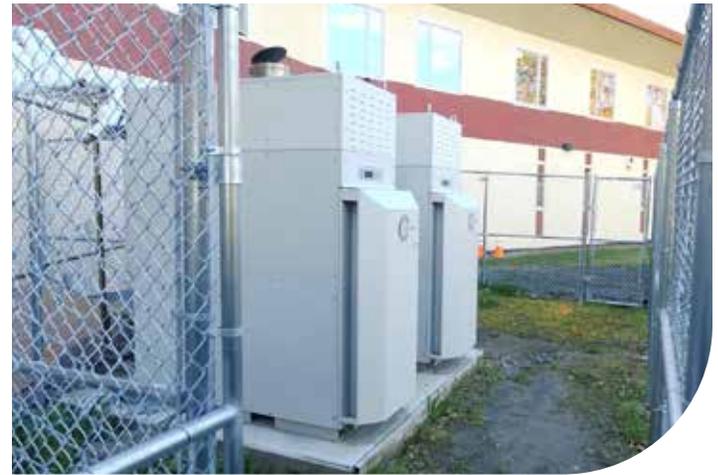
**Two C65 ICHP microturbines provide all of the medical facility's thermal and electrical needs, decreasing their carbon footprint by more than 70% and reducing noise pollution.**

In the upgraded system, hot water flows through an isolated loop to the facility's heat exchanger, the building's primary boiler. During winter months, when the facility is consuming all the heat and hot water it produces, the CHP system runs at efficiency between 85-90% efficiency—a major improvement.

The system runs in "dual-mode," parallel with the grid, so that in the event of a power outage, the microturbine system takes the entire load of the building. Once the grid comes back online and is stable for a minimum of five minutes, the system can re-connect to the grid.

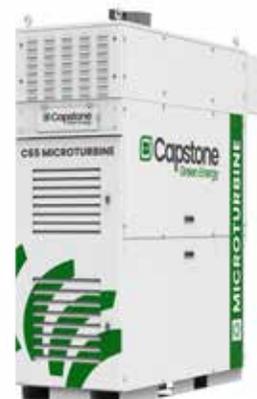
## Capstone C65 ICHP Microturbine

**A C65 provides up to 65kW of electrical power while the UL-Certified C65 ICHP provides up to an additional 150kW of thermal power for CHP and CCHP applications.**
